# **quinquennial inspection**

**church of st. mary • chadwell**

**pcc of st. mary • wycombe & chadwell**

date of inspection: 9th july 2021

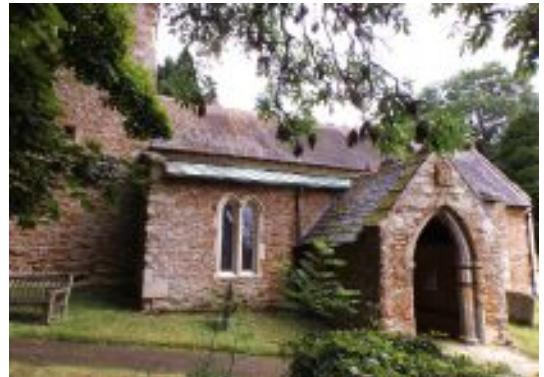
*Below: General view of the church from the south.*

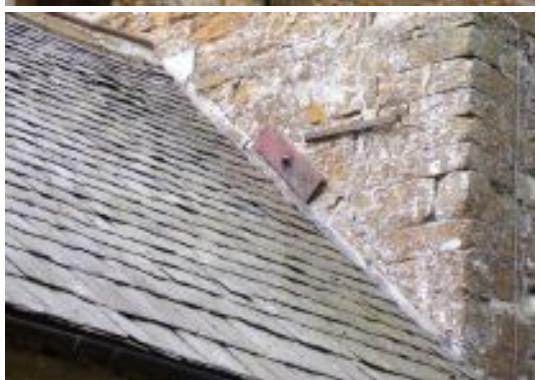
- i South pitch is of Swithland slate laid to diminishing courses with red clay roll top ridge tile containing some crested ridge tiles. Of those crested ridge tiles remaining one or two of the decorations are broken. There are a few gaps in the pointing and at least one ridge tile that has been replaced since the last inspection. One ridge tile has also been replaced in the past. Currently all slating appears to be complete and in satisfactory condition to the south pitch. Lead cover flashings to each end appear to be satisfactory and the condition of the soakers could not be confirmed but there are no obvious leaks internally at present.
- ii North pitch is of Swithland slate laid to diminishing courses, patch repairs carried out since the last inspection but generally the roof covering seems to be intact but there are

Above: View of the south aisle copper roof. Below: South aisle roof detail and patch repair. Second below: Nave south roof pitch. Third below: Nave north roof pitch abutting the tower. Bottom: Nave east parapet wall and flashings.

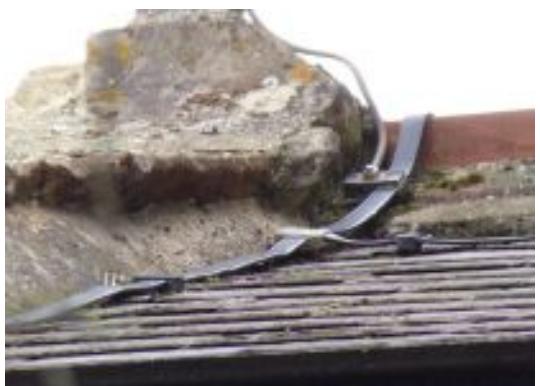
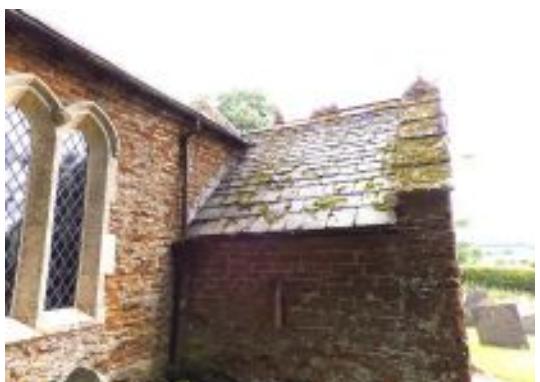
- ii The north pitch is of Swithland slate laid to diminishing courses with clay red ridge tiles to the top, as mentioned previously. Some weathering to the ridge tiles, the roof slating is generally covered in a layer of patchy moss. Two slates in the middle of the roof have started to slip and should be checked in due course by a roofer. The lead flashing along the back of the eastern parapet generally seems satisfactory but a section of mortar pointing or flashing to the lower length appears to be working loose.

- iii The step flashing to the nave wall generally appears to be complete but one of the upper sections appears to be loose and requires re-fixing to its lower edge. A section of the lower portion of the flashing has been ripped away and needs to be replaced.

Above: Chancel south roof pitch. Below: Chancel north roof pitch with moss growth. Second below: Torn flashing to the chancel north roof pitch. Third below: View of the lightning conductor on the tower roof. Bottom: Porch west roof slope.

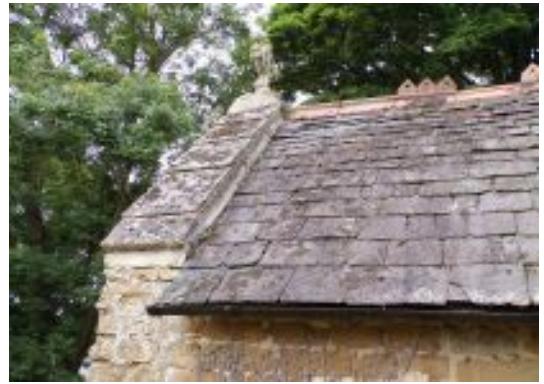
Above: Porch east roof slope. Below: Downpipe east of the porch on the south aisle south elevation. Bottom: Length of plastic gutter on the ground to the west of the porch.

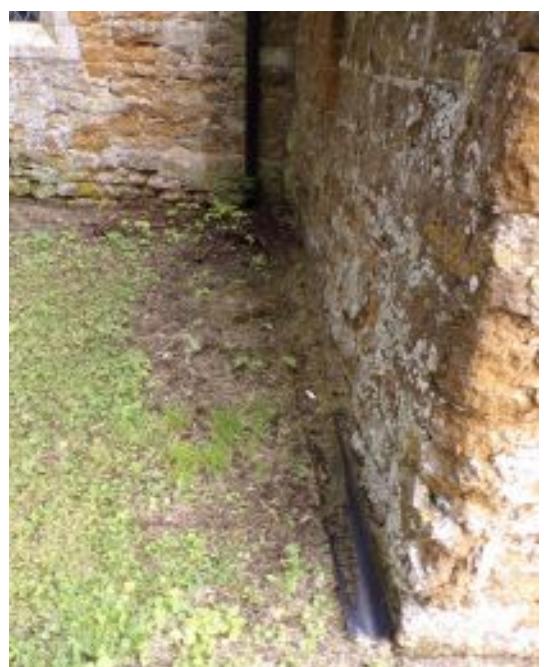
- ii The south aisle has a gutter along the edge, this collects both the south aisle roof water that discharges from the south side of the nave. The gutter is rather undersized and the fall is inconsistent and appears to be full of debris. The water is dripping off significantly above the westernmost window, dripping onto low level stonework and onto the ground. Similarly water is dripping off adjacent to the east side of the porch, saturating the aisle stonework and the installation of larger cast iron guttering, 5 – 6" guttering, is recommended. Downpipes also appear to be undersized – there are downpipes on the east and west sides of the porch, which discharge into a hopper that also accepts water from the porch roof. The downpipes are

approx. 3" diameter and water is running down the face of the eastern downpipe from a joint and the downpipe might be blocked. Water at the base of the downpipe discharges into a length of plastic guttering onto the ground a short distance from the porch but much of the water is also dripping onto the ground around the porch and aisle walls, which is therefore saturated.

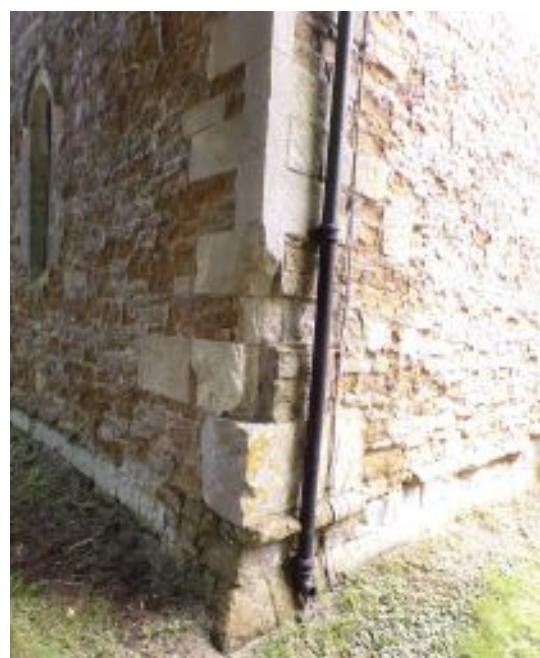
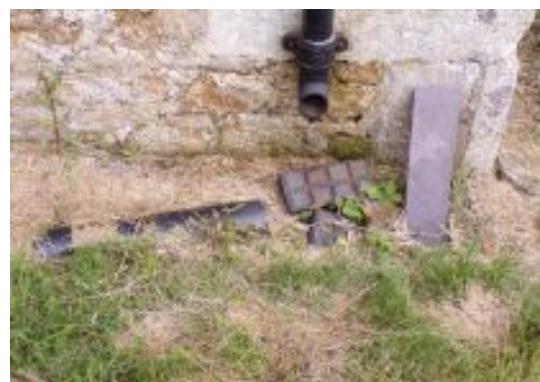
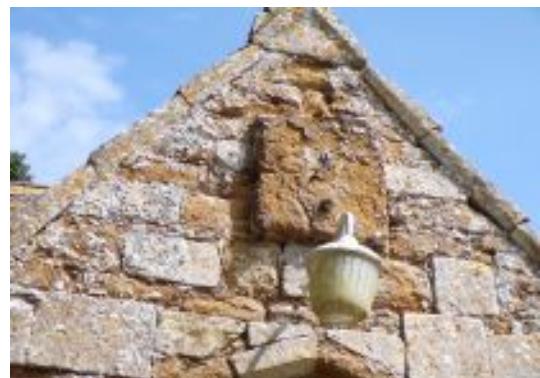
- viii Tower – ogee gutter to the north side of the tower with in the western corner a hopper and 3" downpipe. The downpipe appears to have been repainted in the past but is old, signs of water flow down the front face of the pipe, possibly leakage from joints. To the top there is plant growth growing, probably from the hopper. There is some damage to the leading edge of the guttering in the middle. At the base of the downpipe water flows into a short section of metal gutter discharging approx. 2 feet from the base of the wall into the grass.

- ix To the south side of the tower half round guttering, the easternmost section has dropped slightly and water is dripping off the end cap. At the west end of the gutter there is a hopper and downpipe, 3" diameter, the first offset looks rather rusted and there may be leakage from a joint in this area. To the lower offset above the base stage of the tower the bottom section of pipe is broken and water is dripping out. To the very bottom of the pipe such water as makes it here discharges directly onto the ground. Damaged sections of pipe need renewal and the drooping section of the gutter needs to be re-fixed. Installation of a larger downpipe might reduce the risk of blockage in the future. The guttering and downpipe is overhung by a large deciduous tree, sycamore or similar, and leaves will block rainwater goods.

*Above: Base of the tower and short section of metal gutter taking water from the tower base. Below: Downpipe to the tower south face. Third below: Downpipe base with plastic gutter to take water. Bottom: Porch parapet and high level stonework to the south gable elevation.*

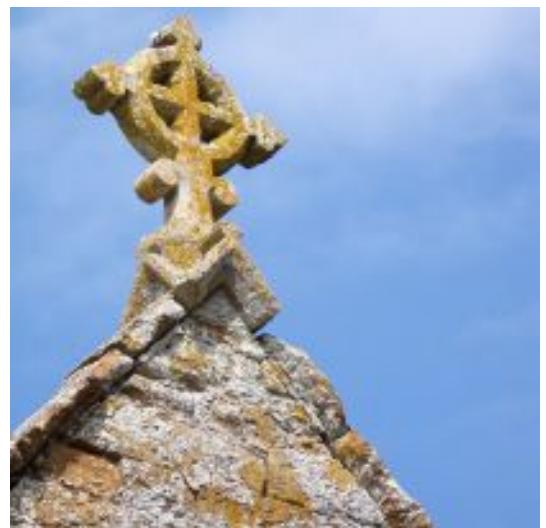
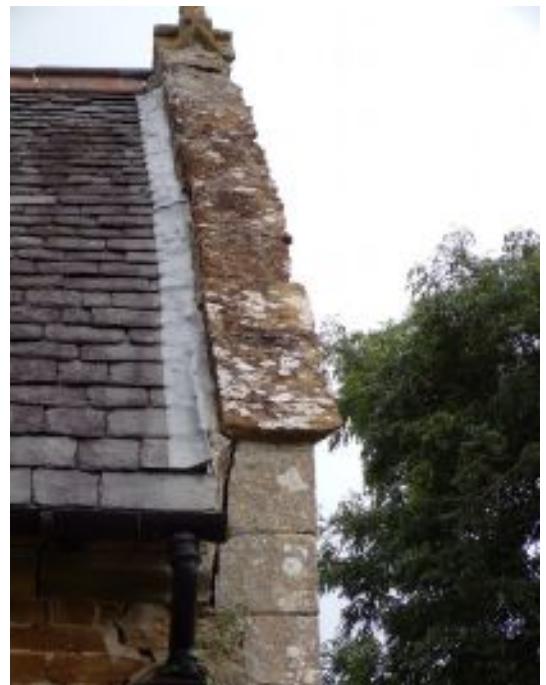
Above: Nave eastern parapet with gaps to coping stones.  
Below: Chancel cross to the eastern gable. Second below: View of the chancel east parapet. Bottom: Tower east gable parapet.

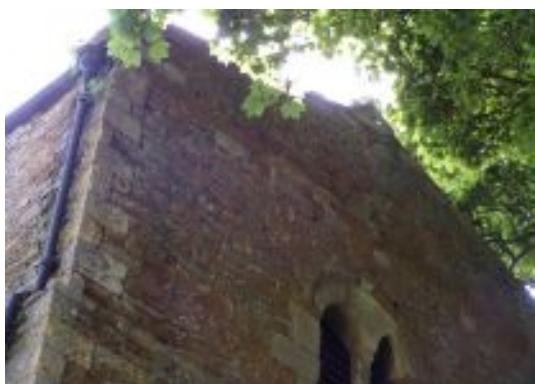
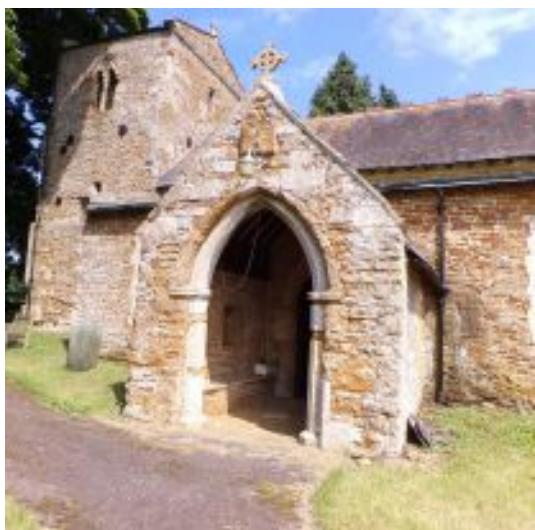
*Above: Copings and kneeler stone to the tower south parapet.  
Below: Tower western parapet obstructed by the tree. Below:  
South gable elevation of the porch. Bottom: Porch east  
elevation.*

be carried out carefully by a skilled stonemason using lime mortar. Some light dressing of the ironstone to remove loose material might be undertaken as part of the same project. There is some evidence of past repointing with a cementitious ribbon pointing, which should be avoided at all costs and may well be contributing to the damage to the ironstone. Despite the weathering of the ironstone no significant replacement of blocks appears necessary at present. The iron stone block of the sundial has split due to the corrosion of the redundant iron fixings. This needs urgent consolidation and the removal of the fixings.

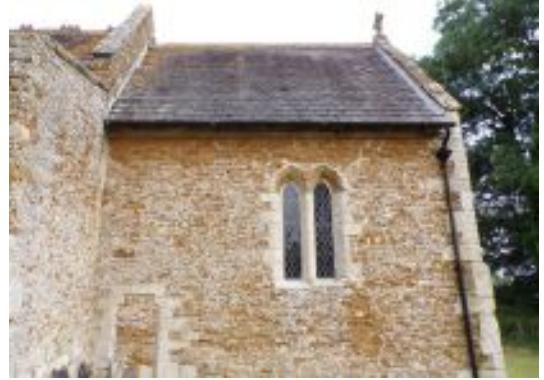
- i Contains old window with ironstone surround and central mullion, now virtually disguised and pointed over with ribbon pointing. A few limestone blocks to the corner, otherwise generally of ironstone mostly brought to courses but some random rubble as well. Various phases of repointing, including some cementitious ribbon pointing, which should certainly be avoided in the future. Consolidation of the wall, including the removal of the cementitious mortar is desirable. There is a gap forming where the wall abuts the tower, which is up to 10mm wide, and there are some signs of movement to the southern corner with cavities up to 15mm wide between the wall and the quoin stones, although later mortar to an extent disguises this. The bottommost corner stone is of ironstone and is in a poor condition, which may not be helping the support of the limestone blocks above and the lowermost limestone block appears to have split vertically within its depth and needs to be replaced.

Above: View of the chancel south elevation. Below: View of the chancel east gable elevation. Bottom: Cracking to the north side of the chancel east elevation.

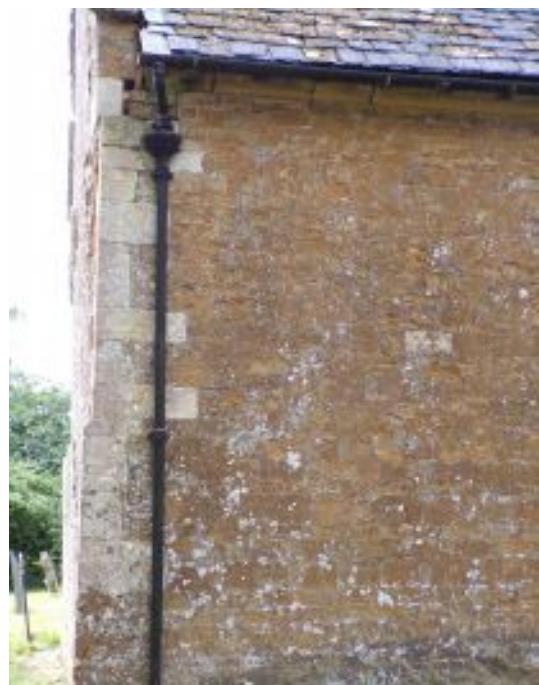
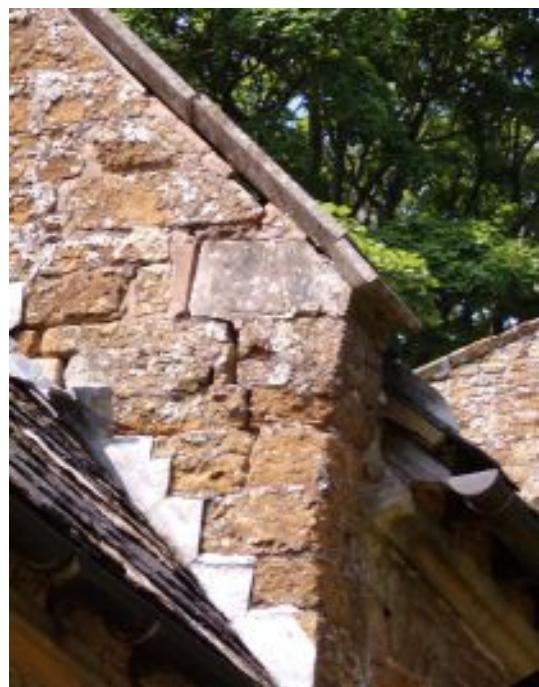
*Above: Chancel north elevation. Below: The north east corner of the chancel north elevation. Bottom: Cracking to the nave east elevation seen above the chancel roof.*

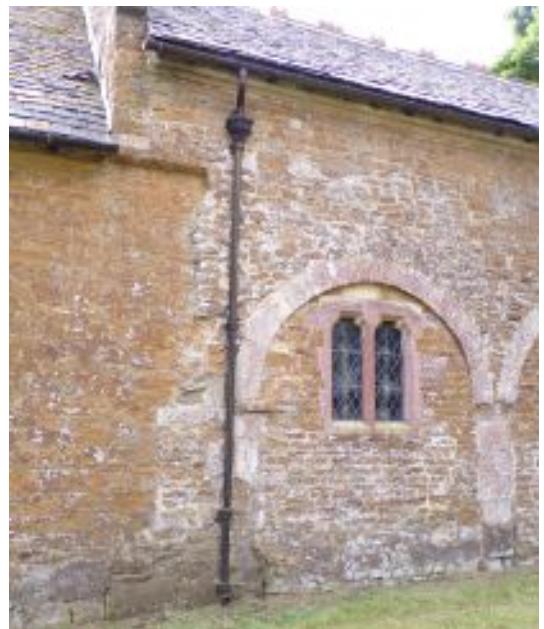
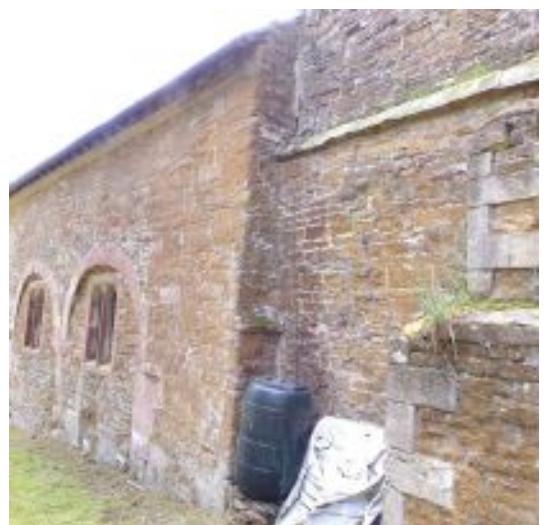
Above: View of the north side of the church. Below: The eastern arcade of the nave north elevation. Second below: Nave west elevation to the north of the tower. Bottom: High level stonework to the nave west elevation north of the tower.

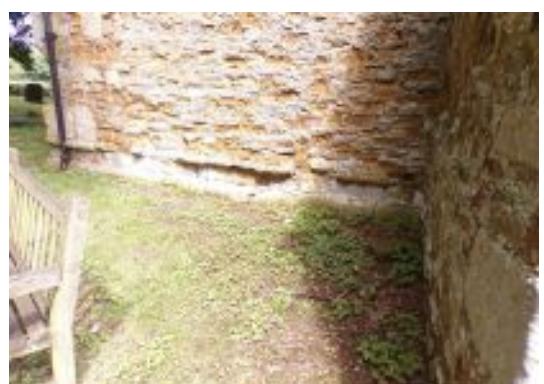
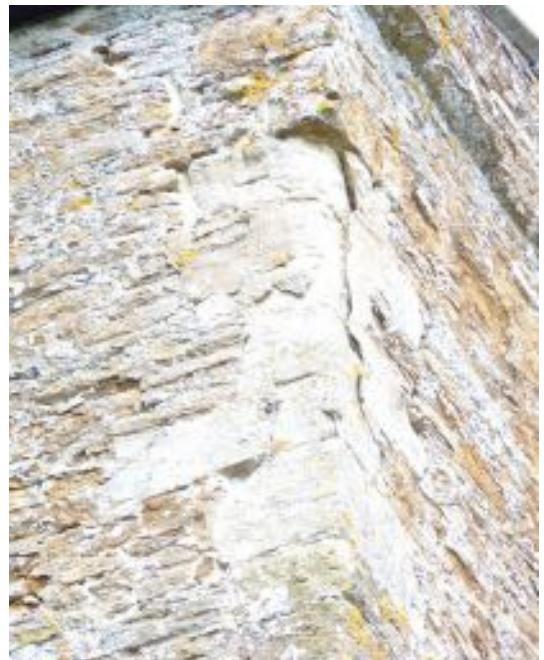
*Above: View of the tower south face. Below: The lower stonework to the tower south face. Bottom: Middle stage of the tower south face with 5 blocks to the western corner needing*

are in a poor condition - 5 have reached a point where they should be replaced. There is a small window into the intermediate chamber in the middle of the wall with part limestone surrounds but ironstone head. There are then 4 patras plates, circular in design with light rust associated with the internal tower strengthening. To the eastern corner some further limestone blocks with evidence of a very extreme cementitious ribbon pointing, which is pretty unattractive and again the middle stage of the tower really needs conservation by a skilled stonemason. Ironstone faces are failing gradually but the main need is for careful removal of inappropriate mortars and consolidation with soft lime mortar (approx 20 m<sup>2</sup>). Some work to stabilise the corner quoins on the western corner is also needed and the patras plates need painting in due course.

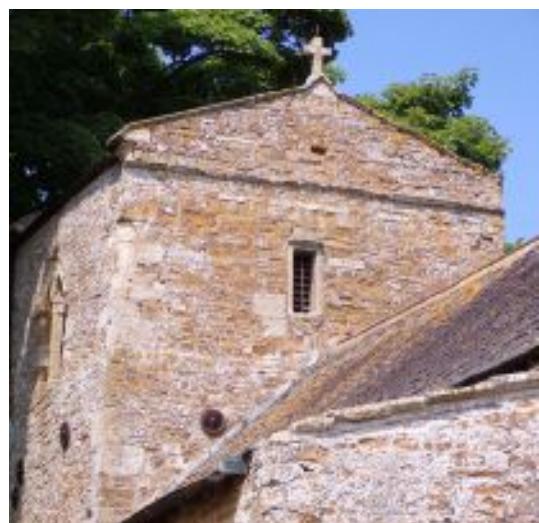
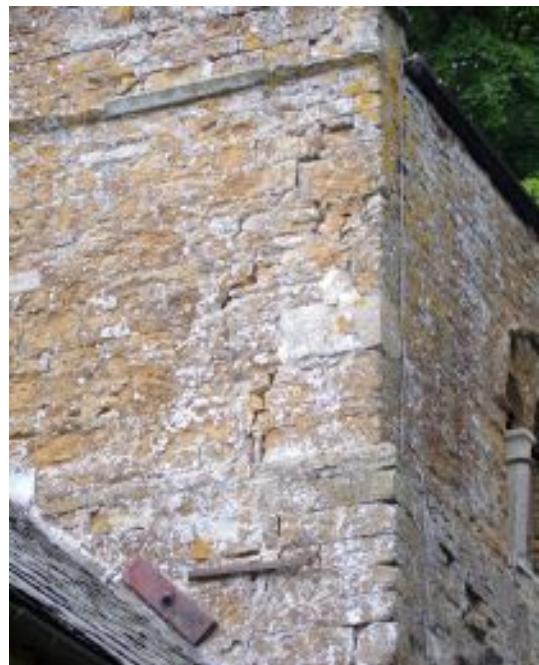
*Above: Belfry window to the tower south face. Below: View of the tower east elevation. Bottom: Stonework detail to the east face of the tower.*

cracking up to 12mm wide vertically behind the stones to the corner with open joints evident. At lower level some evidence of more recent repointing. There is an old iron cramp, which is now open ended at the northern end, having come loose from whatever fixing point it was designed for. Clearly movement has been along-standing issue in this corner, perhaps now stabilised by the new internal cage, nevertheless there is still a need for external consolidation and repointing (approx 15 m<sup>2</sup>). The external ironwork needs to be repainted. The central rectangular window has a vertical central bar, possibly originally glazed and this being part of the fixing of the glazing.

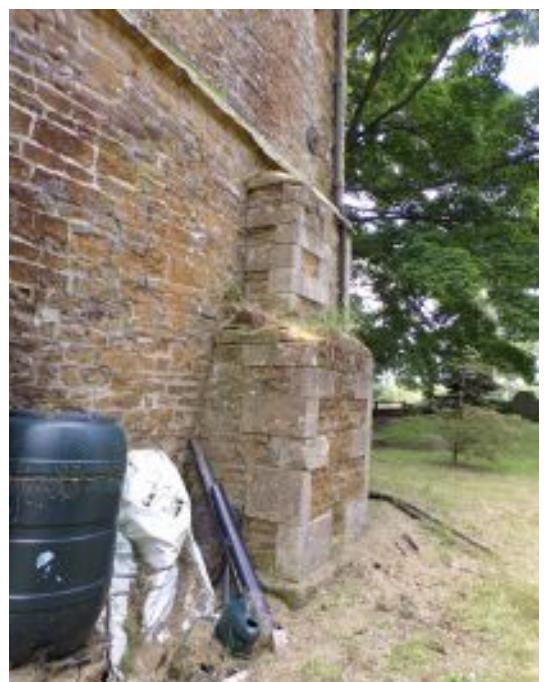
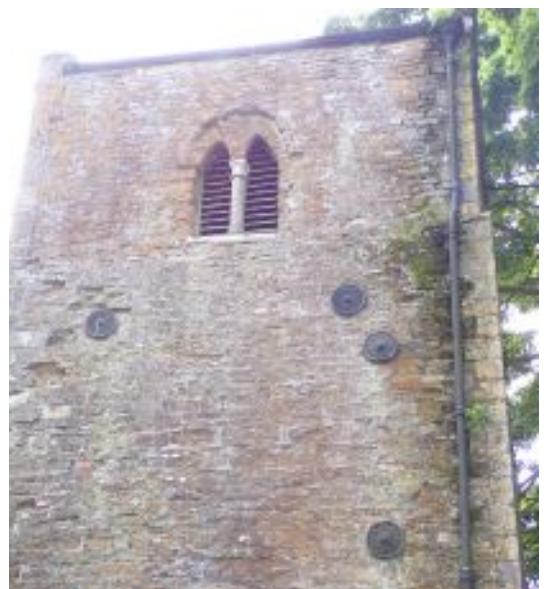
*Above: View of the tower north face. Below: Lower stonework and buttress to the tower north face. Bottom: Belfry level to the tower north face.*

the western corner some evidence of some ribbon pointing in cement, which ideally should be removed and replaced. Some cracks at lower level have been repointed in this stage towards the eastern corner and to the angle to the nave, somewhat crudely done and again evidence of gradual movement needing monitoring or remedial work. Some of this may have been controlled by the installation of the safety cage inside the tower.

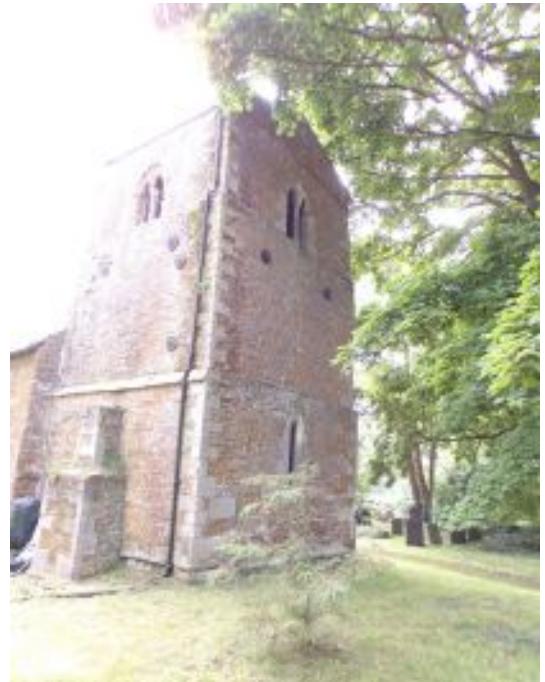
The middle stage is generally of plain ironstone except for limestone blocks at the corners, the limestone blocks are pitted on the north side but not particularly significant. The decay is more significant on the southern corner and some pinning or replacement might be needed. The wall generally of coursed or random ironstone with various stages of repointing, vertically up the middle of the wall is evidence of a band of perhaps cementitious mortar perhaps used to fill a degree of movement in the wall. Beneath the cill of the belfry window the stonework is in quite poor condition and needs consolidation. Elsewhere across the wall there is need to remove loose mortar and consolidate carefully with soft lime mortars. Two patras plates

*Above: View of the west face of the tower. Below: Lancet window to the lower stage of the west face of the tower.*

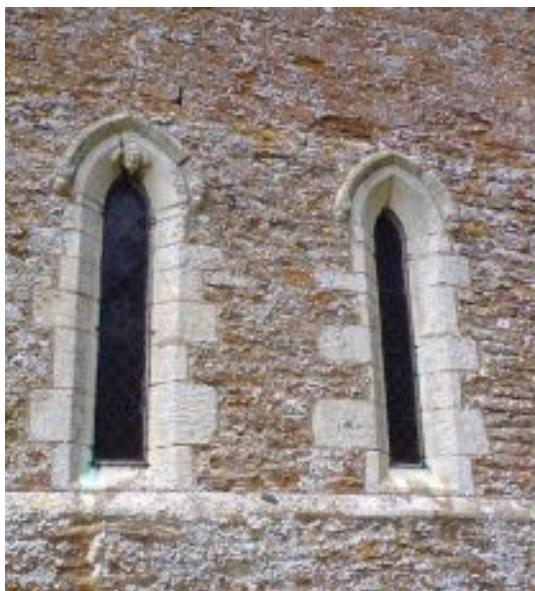
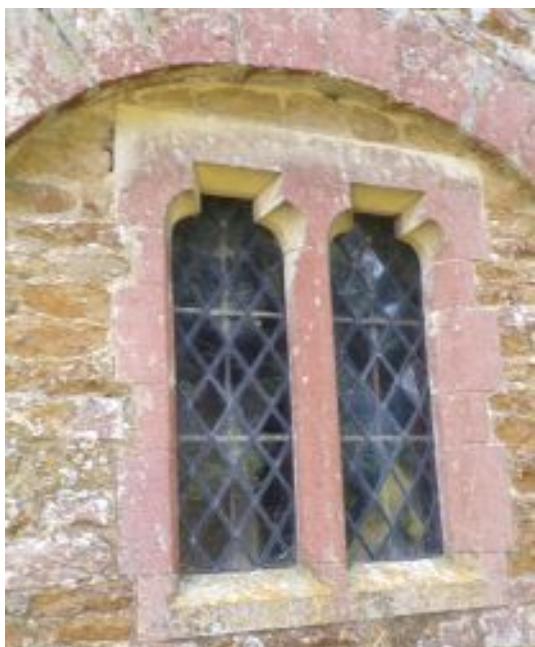
- W2 In the east wall of the chancel, lancet window with limestone surround, the surround generally in satisfactory condition but some repointing to open joints desirable. There is a stainless steel window guard fitted; there is copper staining onto stonework from a previous guard. Window glass is patterned and coloured, leading seems in reasonable

Above: Porch door into the church. Below: Lancet windows to the chancel east elevation. Bottom: Western window in the nave north elevation.

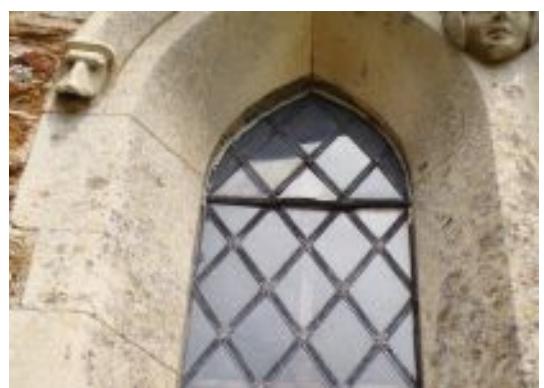
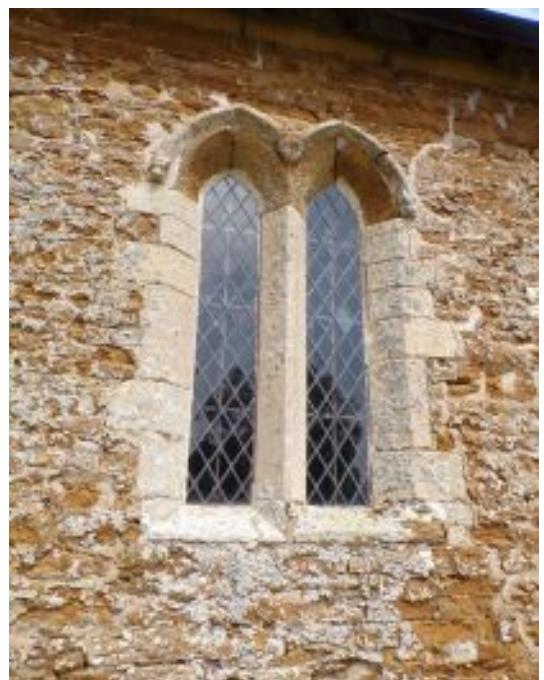
Above: W7 to the west end of the south aisle south elevation.  
Below: Detail to the central window in the south aisle south elevation. Bottom: W9 to the east end of the south aisle south elevation.

lightly and there is evidence of rather crude pointing in this area. The jambs are in reasonable condition, there is some need to consolidate the base of the mullion where the ironstone sill is cracking and new studding to the base of the mullion may be required to make sure the mullion is supported properly. The window glazing is Victorian diamond leaded glass, which appears to have recently been repaired, although the eastern pointing has spalled away (2 linear metres). Internal ironwork/ferramenta is lightly rusted and would benefit from cleaning and repainting.

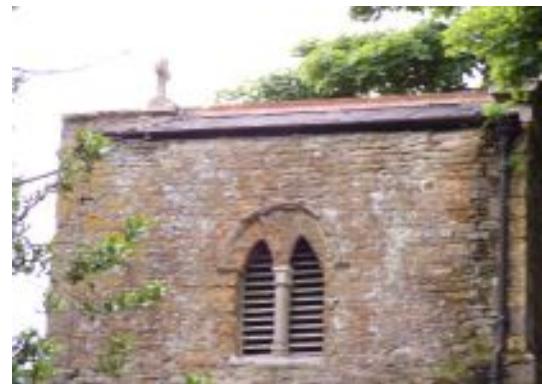
Above: Belfry opening to the north side of the tower - W15.

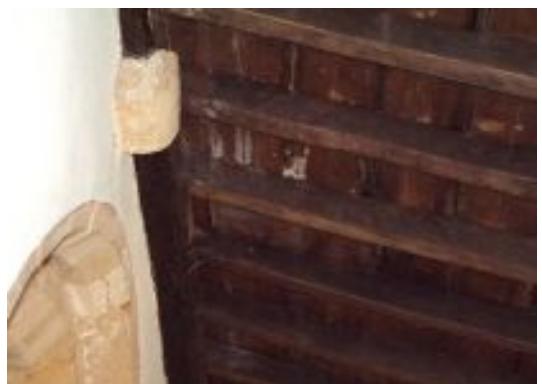
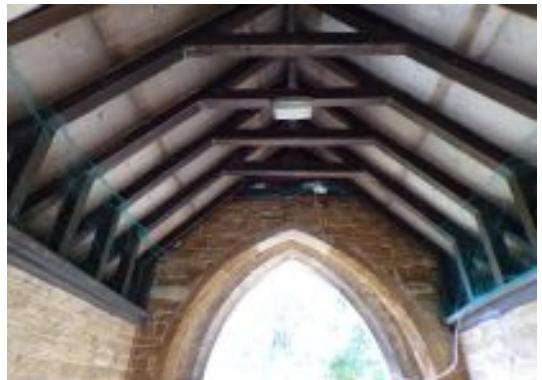
Above: View of the south aisle ceiling structure. Below: Some white staining to the south aisle ceiling. Bottom: Porch ceiling structure.

flaunching between the ends. The underside of the roofing battens have been lined with plywood, exterior quality, probably originally plaster and the plaster worked loose. There is a ridge board running along the length of the rafters but no other bracing. Generally all seems in reasonable condition, there may be some pin holes from woodworm in the plywood sheets, particularly against the aisle wall and evidence of some damp staining of the plywood again against the aisle wall at low level, particularly on the east side. Some of the plywood panels on the west side appear to have a layer of paint, which does not seem to relate to the current roof structure so the boarding may have been reused somehow. The boarding could be painted to approve the appearance of the porch but generally all is satisfactory. Chicken wire has been stuffed behind the rafter against the aisle wall to prevent nesting birds, although this is a little unsightly and in due course a timber fillet or similar could be shaped and installed.

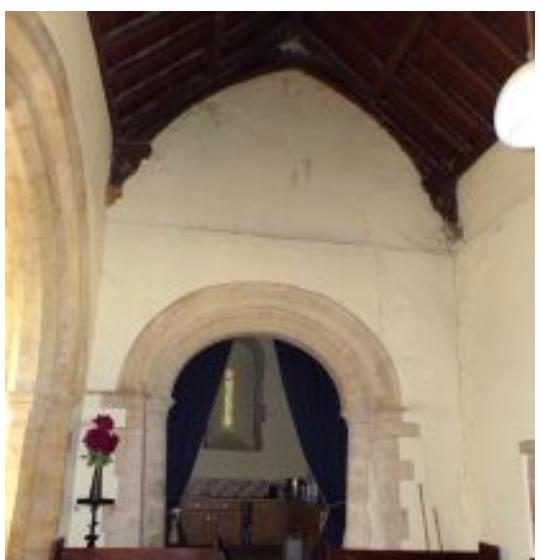
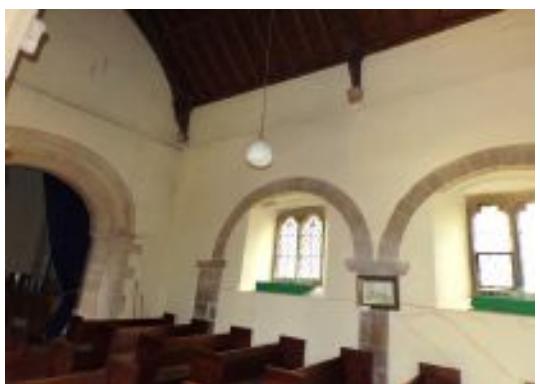
*Above: View of the nave east wall chancel arch. Below: View of the nave west wall tower arch. Second below: Nave north wall. Bottom: Cracking at high level to the nave north wall.*

full height towards the purlin. There is a radiating crack towards the eaves in the main roof on the north side of the nave. There is potential for areas of plaster to be loose and the cracking in the plaster, which must have occurred since the last redecoration, is also noteworthy. Further slight cracking down the back of the plaster near to the northern corner at lower level and the plaster has been patched in the past at low level. There is slight algal bloom on the lower stonework of the respond on the south side.

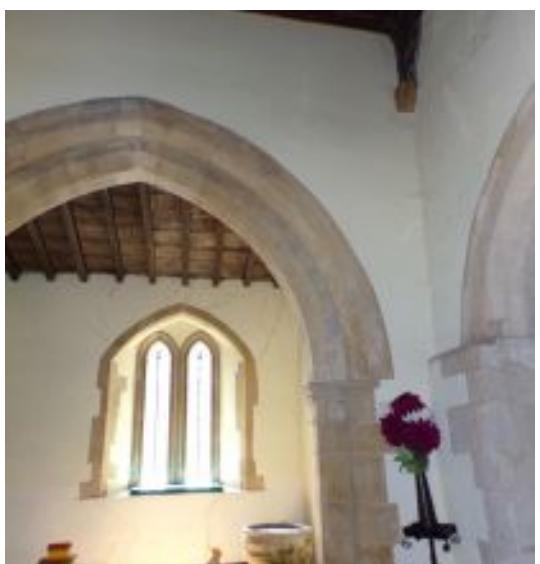
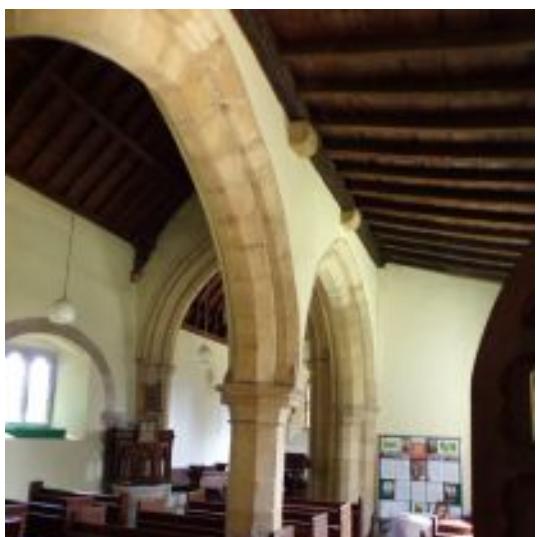
*Above: Cracking to the eastern pillar of the nave north wall.  
Below: Nave south arcade. Second below: Western arch of the nave south arcade. Bottom: North arcade of the south aisle.*

crack has reopened since the last redecoration by a modest amount. Above the centre arch of the arcade there are some almost horizontal cracks, which have been filled in in the past, and one vertical crack from near the west side of the westernmost arcade arch. These cracks have been filled but have re-opened since the last inspection. Exposed stonework to the arcade arches and pillars generally seem to be in good condition.

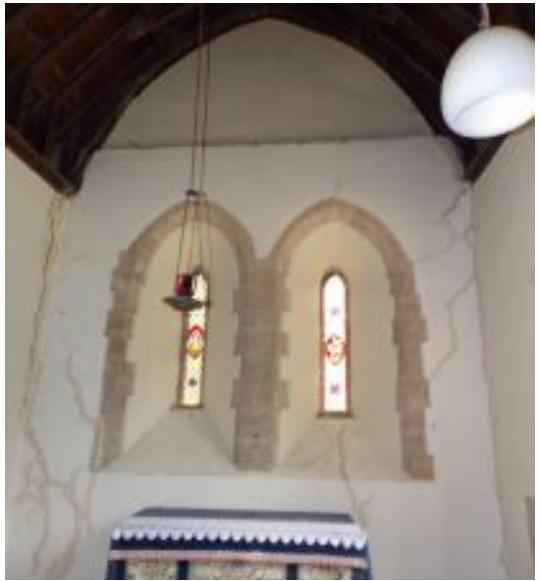
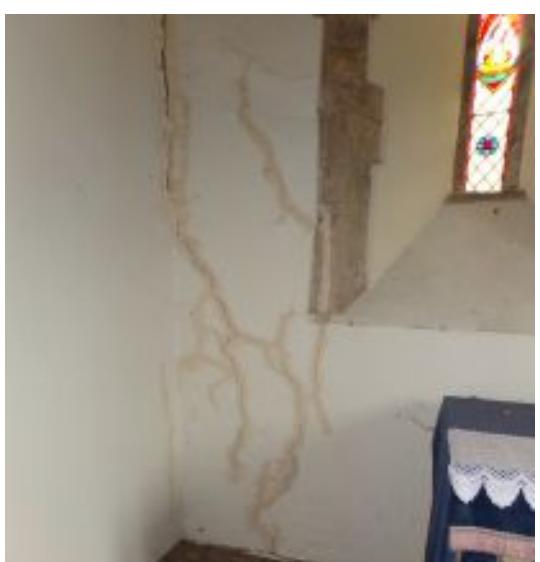
*Above: South aisle south wall east end. Below: South aisle south wall west of the entrance door. Second below: Nave east wall. Bottom: Cracking to the nave east wall.*

have been infilled in the past generally and have not reopened since. There is, however cracks in the angles of both the north and south walls, which has reopened to a modest degree, perhaps about 2mm.

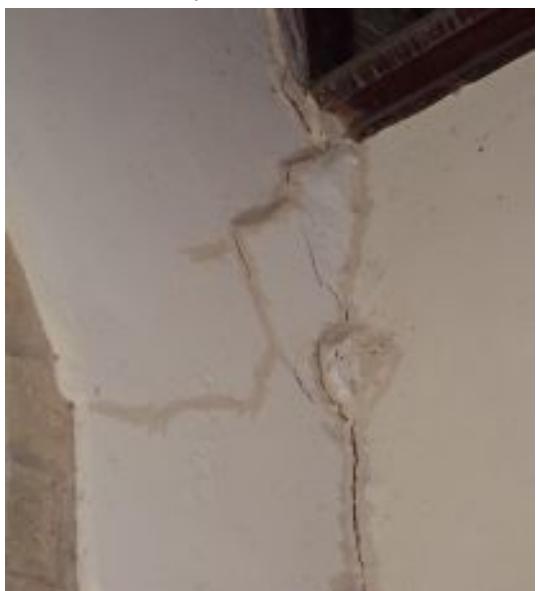
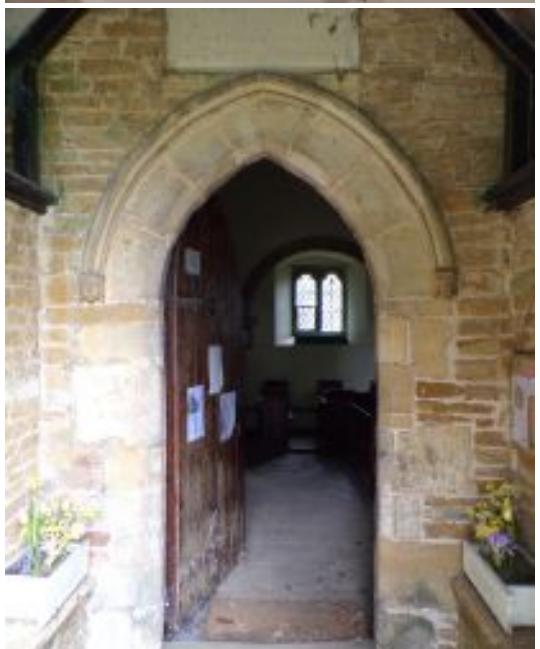
*Above: Chancel west wall chancel arch. Below: Cracking to the angle of the chancel east and south walls. Bottom: Porch north wall and doorway into the church.*

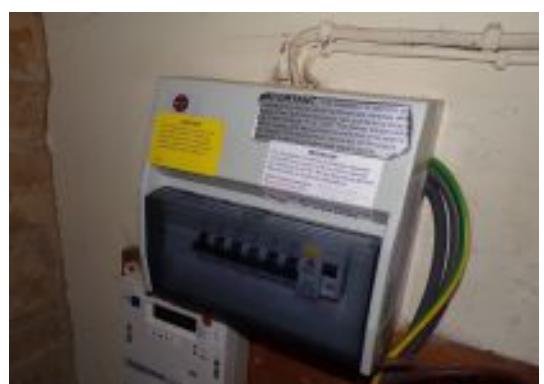
*Above: The electrical supply, which is now switched off.*
