# **quinquennial inspection**

**church of st. mary • chadwell**

**pcc of st. mary • wycombe & chadwell**

date of inspection: 9th july 2021

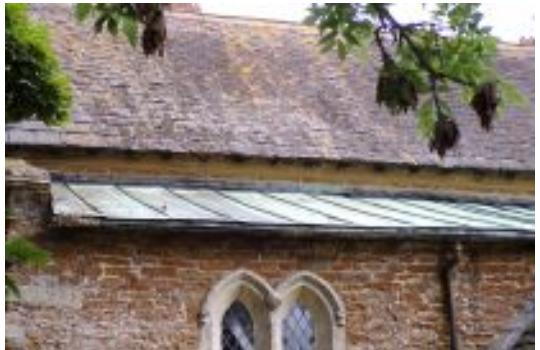
- ii Copper flashings generally to each end parapet and to the top flashing. There have been some problems with the copper sheets deteriorating where the water discharges from the nave roof above, including acidic deposits from the lichen growing on the southern slating. As a result some patch repairs have been carried out and there may be a need for these to be carried out periodically in the future as the copper thins. It may be helpful to install a sacrificial band of copper or lead, however give the relatively small roof area and the propensity in the area for lead and copper to be stolen, consideration might be given to replacing the copper with stainless steel or zinc, but probably the former in this case. This could be installed with batten rolls to improve the appearance of the roof covering.

Above: View of the south aisle copper roof. Below: South aisle roof detail and patch repair. Second below: Nave south roof pitch. Third below: Nave north roof pitch abutting the tower. Bottom: Nave east parapet wall and flashings.

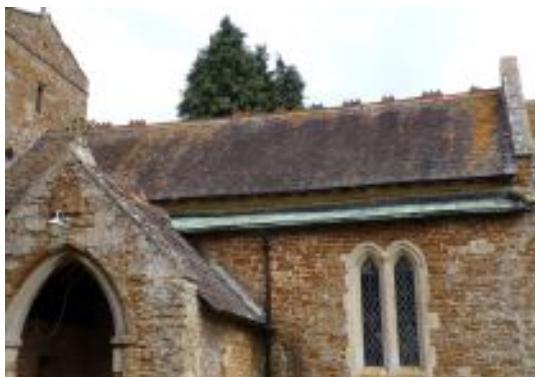
- i South pitch is of Swithland slate laid to diminishing courses with red clay roll top ridge tile containing some crested ridge tiles. Of those crested ridge tiles remaining one or two of the decorations are broken. There are a few gaps in the pointing and at least one ridge tile that has been replaced since the last inspection. One ridge tile has also been replaced in the past. Currently all slating appears to be complete and in satisfactory condition to the south pitch. Lead cover flashings to each end appear to be satisfactory and the condition of the soakers could not be confirmed but there are no obvious leaks internally at present.
- ii North pitch is of Swithland slate laid to diminishing courses, patch repairs carried out since the last inspection but generally the roof covering seems to be intact but there are

perhaps one or two slates starting to work loose and looking slightly uneven, particularly towards the tower. The ridge tiles are roll top or crested, as mentioned for the south side of the roof.

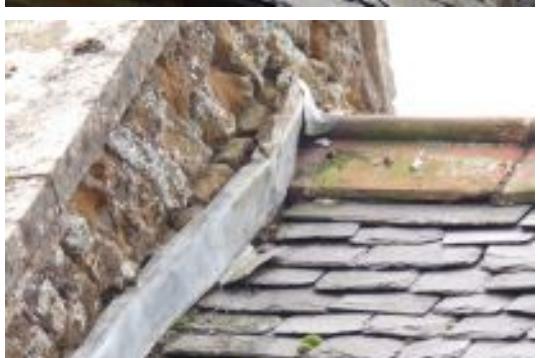
- iii The flashing to the rear of the eastern parapet has been partially repointed but the upper 2 - 3m appears to have sprung out of the masonry and needs to be re-fixed or replaced. The flashing abutment to the tower is rather shallow but in part has to fit underneath a steel reinforcing plate, otherwise is satisfactory at present. Slates are a bit uneven to the immediate corner of the tower but this is where they seem to follow the arrangement and aligning of the stone walling beneath. The upper slate of this group lacks an effective top flashing or weathering, with just a mortar fillet, which may not be fully effective. There are at least 6 slates slipping near the tower.

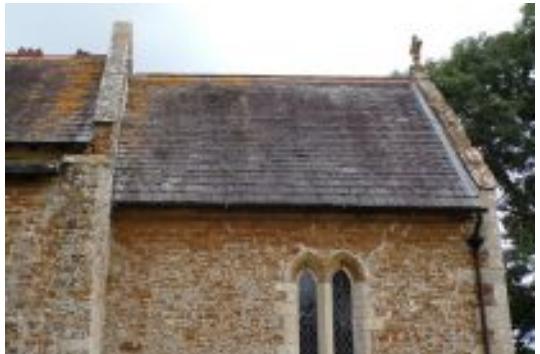
- i The south roof pitch is of Swithland slate laid to diminishing courses with red clay roll top ridge tiles. The western most ridge tile is in a seemingly poor state, missing most of its top roll and one or two gaps visible in joints between ridge tiles, particularly to the first two from east. Swithland slating has been repeatedly patched, the flashing to the rear of the eastern parapet has been renewed but the lower 1 - 1.5m does not appear to be dressed into or under the stonework making it ineffective - all slating currently appears to be complete. The step flashing to the nave gable also seems to be satisfactory at present, although from inside daylight is visible through the apex and the front meaning there is no saddle flashing. Approx 5 slates are fixed to clips/tingles.

Above: Chancel south roof pitch. Below: Chancel north roof pitch with moss growth. Second below: Torn flashing to the chancel north roof pitch. Third below: View of the lightning conductor on the tower roof. Bottom: Porch west roof slope.

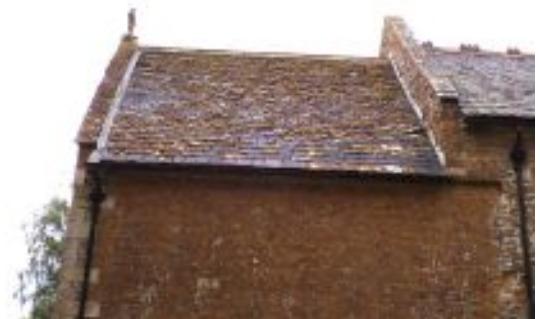
- ii The north pitch is of Swithland slate laid to diminishing courses with clay red ridge tiles to the top, as mentioned previously. Some weathering to the ridge tiles, the roof slating is generally covered in a layer of patchy moss. Two slates in the middle of the roof have started to slip and should be checked in due course by a roofer. The lead flashing along the back of the eastern parapet generally seems satisfactory but a section of mortar pointing or flashing to the lower length appears to be working loose.

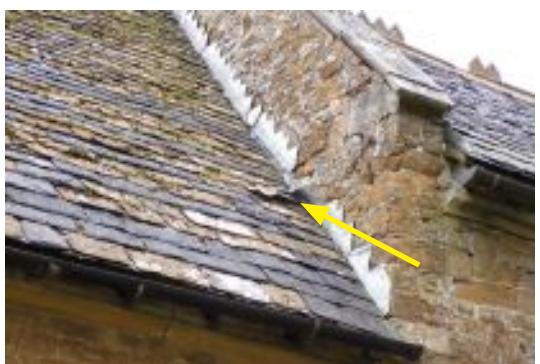
- iii The step flashing to the nave wall generally appears to be complete but one of the upper sections appears to be loose and requires re-fixing to its lower edge. A section of the lower portion of the flashing has been ripped away and needs to be replaced.

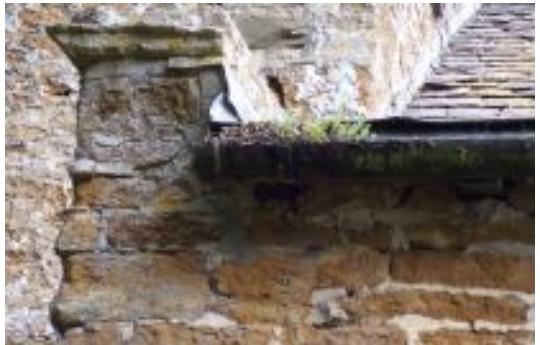
- ii The south aisle has a gutter along the edge, this collects both the south aisle roof water that discharges from the south side of the nave. The gutter is rather undersized and the fall is inconsistent and appears to be full of debris. The water is dripping off significantly above the westernmost window, dripping onto low level stonework and onto the ground. Similarly water is dripping off adjacent to the east side of the porch, saturating the aisle stonework and the installation of larger cast iron guttering, 5 – 6" guttering, is recommended. Downpipes also appear to be undersized – there are downpipes on the east and west sides of the porch, which discharge into a hopper that also accepts water from the porch roof. The downpipes are

*Above: Gutter to the south aisle west end with weed growth.  
Below: Downpipe to the east end of the chancel south elevation. Second below: Base of the downpipe to the chancel north elevation. Bottom: Tower downpipe.*

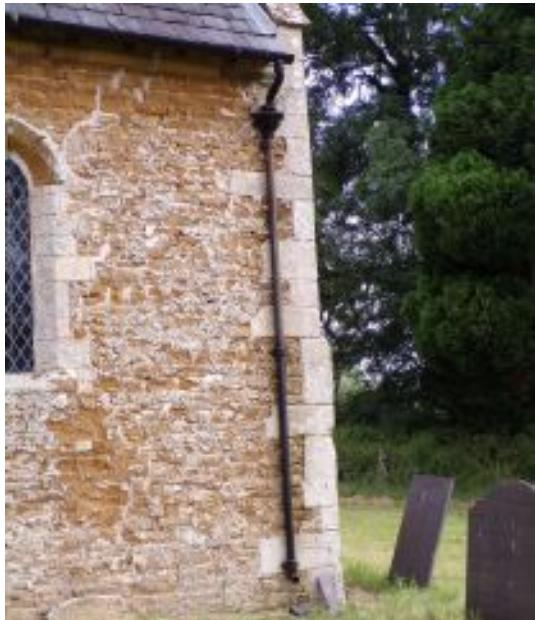
- v The chancel has half round guttering on the south side, possibly undersized for the size of roof area and 5" guttering would be better but there is no obvious signs of overflow. At the east end there is a swan neck into a hopper and then into a downpipe, which again is somewhat undersized but fairly new and again some signs of overflow down the lower section of pipe on the front face suggesting that there is leakage from a joint and perhaps a capacity issue during heavy rain. Along the base of the wall there is a concrete channel, which may have once collected water from the roof edge. To the base of the downpipe there is a blue brick, which once supported a length of plastic gutter, discharging water about 1m away from the wall base into the grass. The piece of plastic gutter has moved so water is trickling onto the ground immediately around the base of the wall.

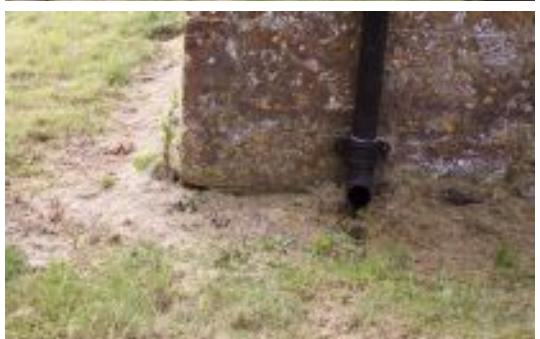
- vi Chancel north side – again half round cast iron guttering on rafter brackets, the fall is a bit uneven and there is the potential for overflow in the middle. A swan neck at the east end descends into a hopper then a 3" downpipe discharging into a plastic length of guttering and then into the grass. The downpipe is in reasonable condition but water is

running down some of the face of the pipe and there may well be capacity issues and again the guttering on the roof is probably a bit undersized. Ground level drainage and rainwater management needs improvement.

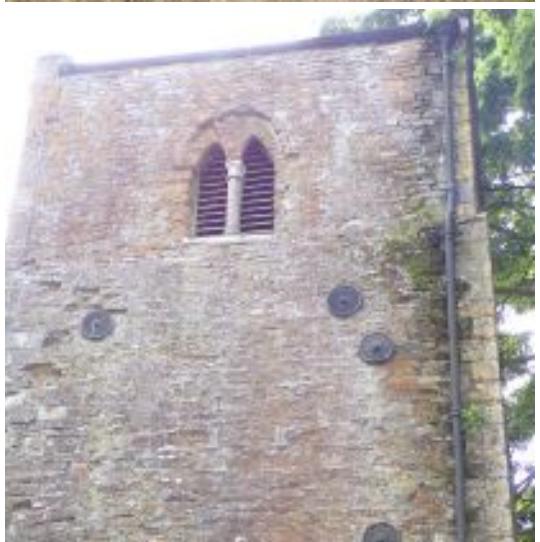
- viii Tower – ogee gutter to the north side of the tower with in the western corner a hopper and 3" downpipe. The downpipe appears to have been repainted in the past but is old, signs of water flow down the front face of the pipe, possibly leakage from joints. To the top there is plant growth growing, probably from the hopper. There is some damage to the leading edge of the guttering in the middle. At the base of the downpipe water flows into a short section of metal gutter discharging approx. 2 feet from the base of the wall into the grass.

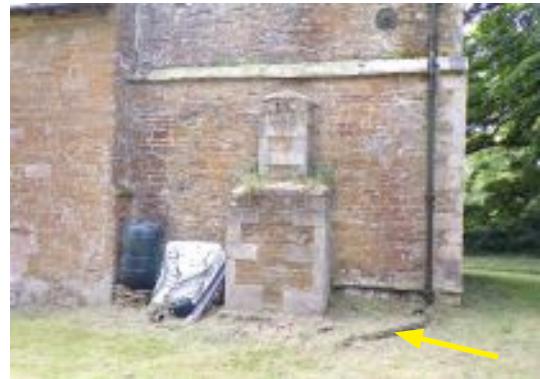
- i There is no foul drainage to the church, the sink in the base of the tower discharges only to a plastic container, which is periodically emptied.
- ii There is no effective surface water drainage serving the downpipes. Generally around the building there are short lengths of plastic gutter, which take water from the downpipes a very short distance and then discharges onto

*Above: Base of the tower and short section of metal gutter taking water from the tower base. Below: Downpipe to the tower south face. Third below: Downpipe base with plastic gutter to take water. Bottom: Porch parapet and high level stonework to the south gable elevation.*

- iii The lack of decent effective below ground drainage may have a contributory factor to some of the movement and cracking seen in church walls and below ground drainage/soakaways is required around the church generally noting that the soil generally is a mixture of ironstone and clay and percolation tests will be required to carefully size and locate effective soakaways. Appropriate inspection chambers/rodding points etc should be installed as part of any new drainage to allow management and maintenance.

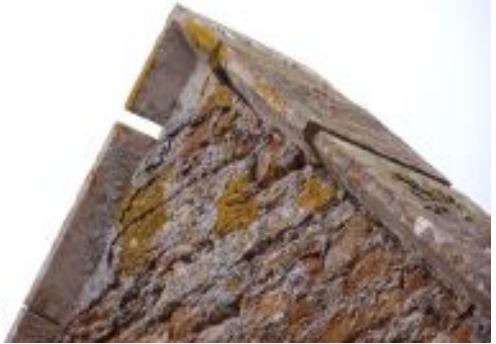
- iv Nave eastern parapet, probably Victorian replacement limestone copings with bottom kneelers, very gappy and there are gaps of up to about 2" towards the tops of the row of copings to the south slope and 4" to the second coping from the top on the north slope where lower units have slid and consolidation of the gable generally and re-pinning and the pointing up of the copings is needed urgently. Lower down there is daylight visible beneath the lower 2 copings on the south slope and there is evidence of movement to the kneelers and associated stonework on both sides of the gable.

Above: Nave eastern parapet with gaps to coping stones.  
Below: Chancel cross to the eastern gable. Second below: View of the chancel east parapet. Bottom: Tower east gable parapet.

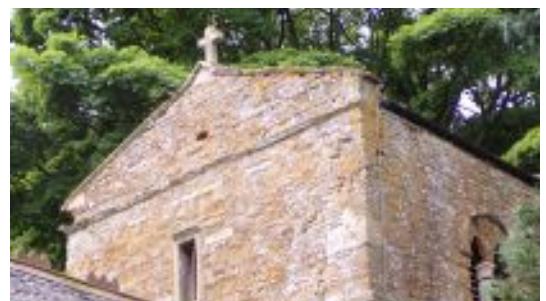
Tower eastern gable parapet has a need for consolidation beneath, as noted elsewhere in this report. The cross to the top of the gable has a steeper pitch to the base stone, which may indicate an earlier roofline. Kneeler stone to the southern end is again suggestive of an earlier steeper roof pitch. Parapet stones on the south side seem in reasonable condition, although the kneeler supporting the copings at the south corner is heavily eroded and needs to be replaced. The copings to the north slope are very much more weathered. The rear of the parapet has been consolidated with mortar in recent years as part of roof repairs.

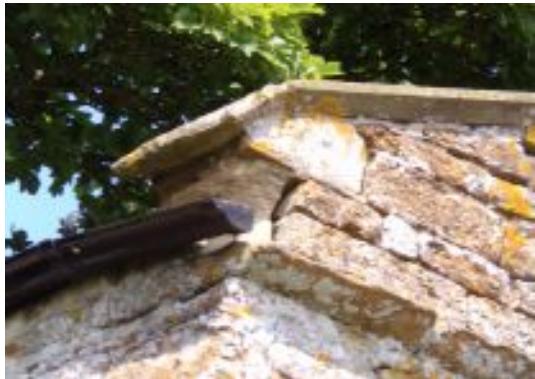
*Above: Copings and kneeler stone to the tower south parapet.  
Below: Tower western parapet obstructed by the tree. Below:  
South gable elevation of the porch. Bottom: Porch east  
elevation.*

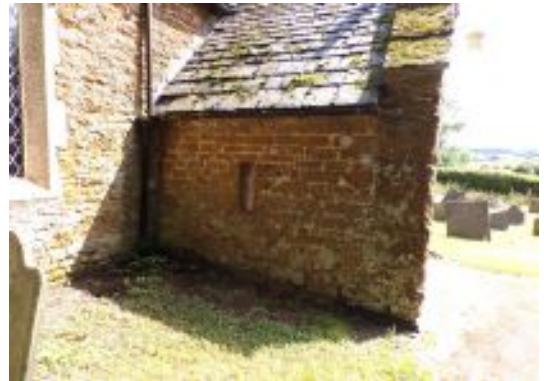
*Above: South porch west elevation. Below:View of the south side of the church. Bottom: South aisle south elevation west of the porch.*

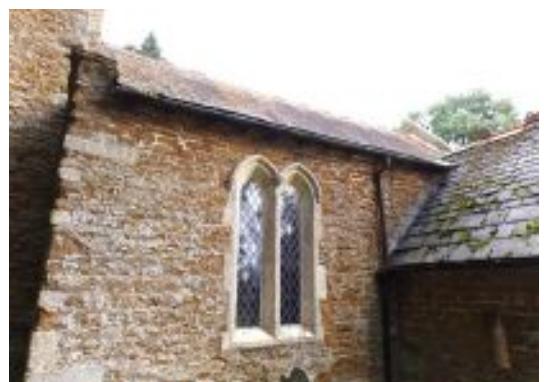
- i To the west of the porch, 2 light wide lancet type window, limestone surround, probably all Victorian in date then to the corner of the wall one or two large limestone quoins, but generally ironstone coursed walling. At low level the wall, particularly beneath the window, has been badly affected by overflow and discharge from the gutter at the head of the wall. A larger gutter as part of rainwater management is needed and then the wall needs to be cleaned down and consolidated at the base. Something of a gap forming around the window surround on the east side and there may be some slight movement in the wall, again probably associated with poor rainwater management.

The wall has been repointed in the past at various times and with various materials. To the east of the window generally a pale, possibly lime based mortar, which has crazed and is falling out in a number of places, covered and disguised by lichen growth. To the back of the downpipe evidence of rather crude cementitious mortar, which should certainly be avoided in the future. Some cleaning down of the stonework and patch pointing is desirable. The head of the wall is largely protected by the roof overhang, the rafter ends extend out to support an end board/tilting fillet. One or two of the rafter ends show signs of light decay and/or beetle activity and again effective rainwater management is required to help protect the rafter ends. The pointing to the top of the flashing to the porch is in a rather crude cementitious mortar and there is some patch pointing underneath the eaves, again in a crude cementitious mortar. Approx 3 m<sup>2</sup> to the base of the wall and east of the window should be repointed.

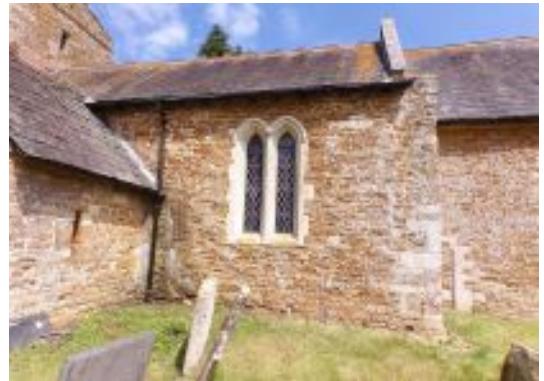
To the east of the porch again a 2 light wide lancet type window with limestone surround, probably Victorian in date, otherwise generally ironstone except for some blocks of limestone to the corner. Behind the downpipe and generally there has been some repointing in a creamy coloured mortar, which has crazed and is falling out widely and there is also evidence of some past cementitious repointing in a ribbon format, which should definitely be avoided in the future. There appears to have been a crack near to the eastern corner, pointed up in a cementitious mortar but has reopened to about 5mm - based on the previous report this movement is ongoing and the crack is widening. Poor rainwater management again may be a contributing factor here, there may be issues with water overflow from the guttering. General repointing of the wall is probably desirable and there are open joints continuously at low level part filled with soil. The limestone surround to the window is in good condition. To the top of the wall rafter ends extend out with one or two replaced sections of boarding above. Most rafter ends appear in reasonable condition with just a light amount of decay in one or two.

Above: South aisle south elevation east of the porch.

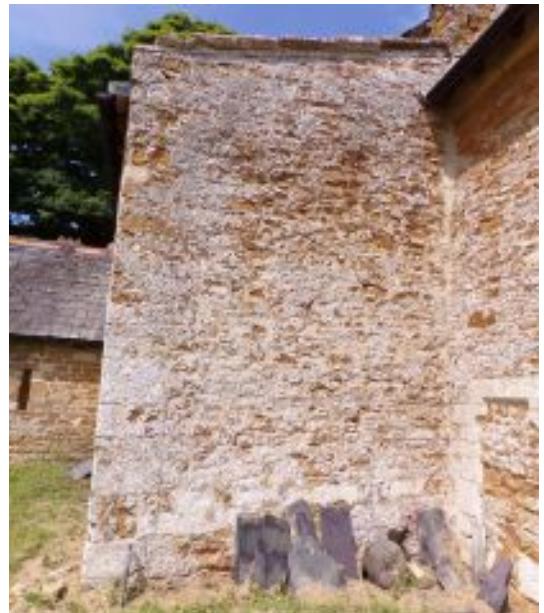
Fairly significant bulge in the ironstone towards the top of the wall, the reason for this is not clear – the wall has been extensively repointed in hard mortars and there has been recent patching, again in a cement rich mix in the angle to the chancel. This has not reopened but there is extensive evidence of bonding issues within the wall and possible slight settlement towards the southern corner. There may also be issues with the bonding of the outer facing with the wall core, much of this is disguised by a thick layer of lichen. The wall is generally of rubble ironstone, the middle section of the wall has been badly pointed up covering much of the face of the stone in places. Consolidation (18 m<sup>2</sup>) and some stone replacement is likely to be needed and again rainwater management at low level needs to be improved.

Below: East elevation of the south aisle. Bottom: West elevation of the south aisle.

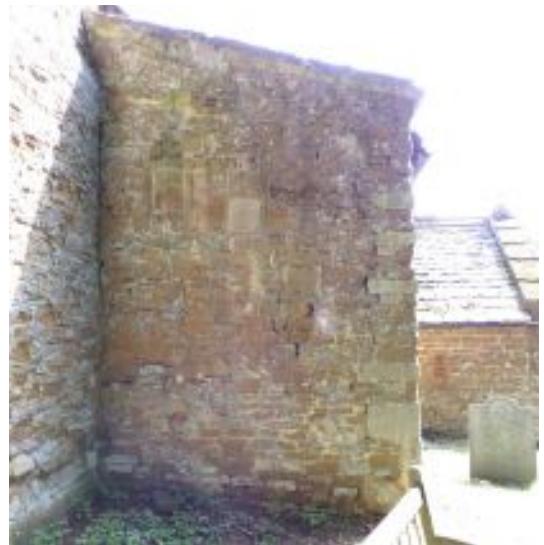
- i Contains old window with ironstone surround and central mullion, now virtually disguised and pointed over with ribbon pointing. A few limestone blocks to the corner, otherwise generally of ironstone mostly brought to courses but some random rubble as well. Various phases of repointing, including some cementitious ribbon pointing, which should certainly be avoided in the future. Consolidation of the wall, including the removal of the cementitious mortar is desirable. There is a gap forming where the wall abuts the tower, which is up to 10mm wide, and there are some signs of movement to the southern corner with cavities up to 15mm wide between the wall and the quoin stones, although later mortar to an extent disguises this. The bottommost corner stone is of ironstone and is in a poor condition, which may not be helping the support of the limestone blocks above and the lowermost limestone block appears to have split vertically within its depth and needs to be replaced.

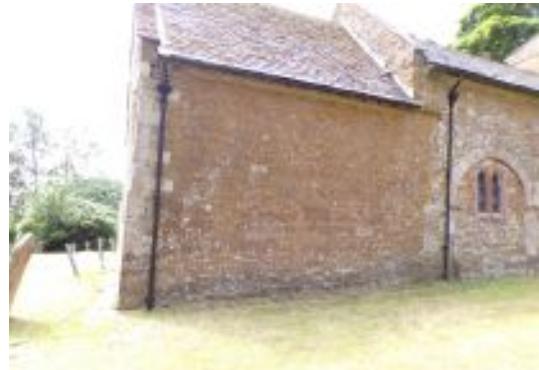
- i Limestone blocks to the corner, sandstone corbel to the base of the roof, otherwise generally of ironstone laid to regular courses but with some rubble work at low level. Most of the ironstone appears to be Victorian in date and probably dates from the restoration, including the roof work. There is a slight step crack running from about midway up in the wall up to the roof line at the east end and there is a second crack about 2.5m from the corner.
- ii Although there is some delamination of the ironstone face the wall appears mostly in satisfactory condition, there is a need however for a few open joints at low level to be pointed up. The north east corner of the chancel indicates that the north wall may be leaning outwards as a panel away from the east wall due to the

*Above: Chancel north elevation. Below: The north east corner of the chancel north elevation. Bottom: Cracking to the nave east elevation seen above the chancel roof.*

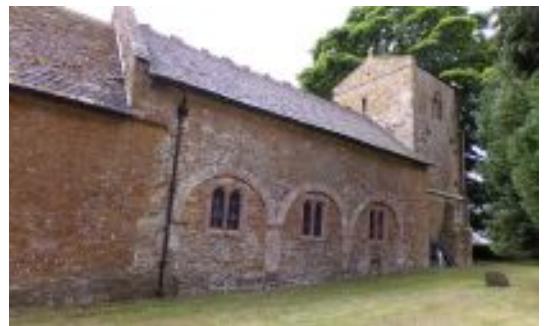
- i Contains the infilled Norman arcade, which is a splendid feature, although the capital stones have been broken off. The arch stones are very clear and a striking feature of this wall, particularly tinted with a reddish colour lichen. Within the arcade the wall has been infilled with generally ironstone rubble, the remains of a piscina is evident behind the downpipe at the east end. To the base of the wall some need for repointing, the westernmost arcade arch appears to have had 2 periods of infilling and includes an old doorway beneath the window. Window surrounds appear to be Victorian in date and have cusp heads to tops of comparatively simple windows with stone lintels.

Above: View of the north side of the church. Below: The eastern arcade of the nave north elevation. Second below: Nave west elevation to the north of the tower. Bottom: High level stonework to the nave west elevation north of the tower.

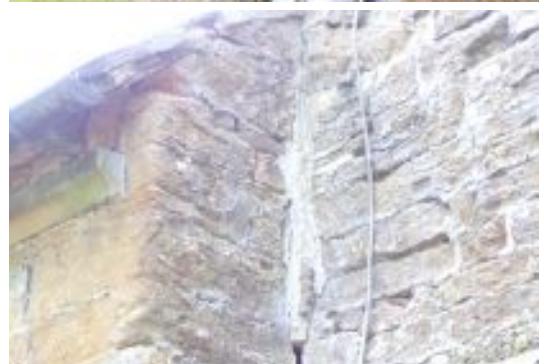
There is an outward lean/bulge to this wall, which is also seen internally and may be historic but the line of the Victorian roof also to an extent follows this bulge. At one stage the wall would have been embraced by the aisle roof, now removed. To the west end of the wall some further evidence of possible bulging at the base of the wall and some cracking around the back of the older stonework to the end of the arcade, which may be indicative of movement.

Seen to the north side of the tower, a narrow band of stone abutting the side of the tower, at high level some comparatively recent infill with some pale probably lime based mortar but some signs of the 25mm wide crack or joint reopening. To the south side of the tower no side of the nave is visible.

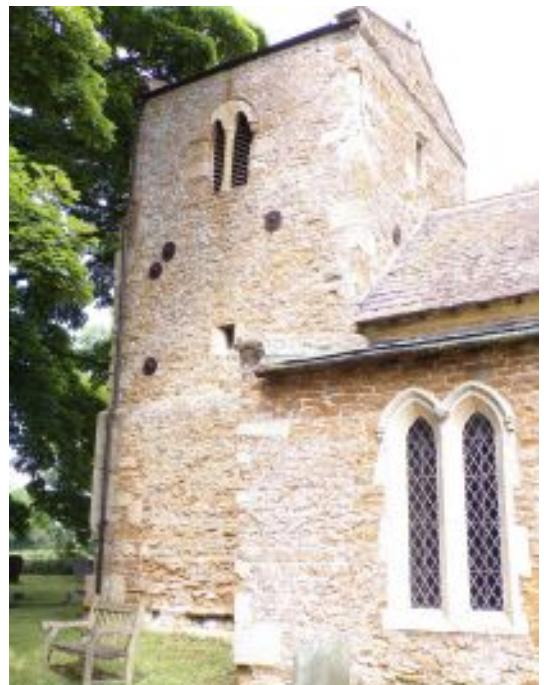
The lower stage has various phases of repointing, the ironstone is weathering back and all generally needs attention by a skilled stonemason, including the removal of loose mortar and repointing with an appropriate soft lime mortar (approx 18 m<sup>2</sup>).

*Above: View of the tower south face. Below: The lower stonework to the tower south face. Bottom: Middle stage of the tower south face with 5 blocks to the western corner needing*

are in a poor condition - 5 have reached a point where they should be replaced. There is a small window into the intermediate chamber in the middle of the wall with part limestone surrounds but ironstone head. There are then 4 patras plates, circular in design with light rust associated with the internal tower strengthening. To the eastern corner some further limestone blocks with evidence of a very extreme cementitious ribbon pointing, which is pretty unattractive and again the middle stage of the tower really needs conservation by a skilled stonemason. Ironstone faces are failing gradually but the main need is for careful removal of inappropriate mortars and consolidation with soft lime mortar (approx 20 m<sup>2</sup>). Some work to stabilise the corner quoins on the western corner is also needed and the patras plates need painting in due course.

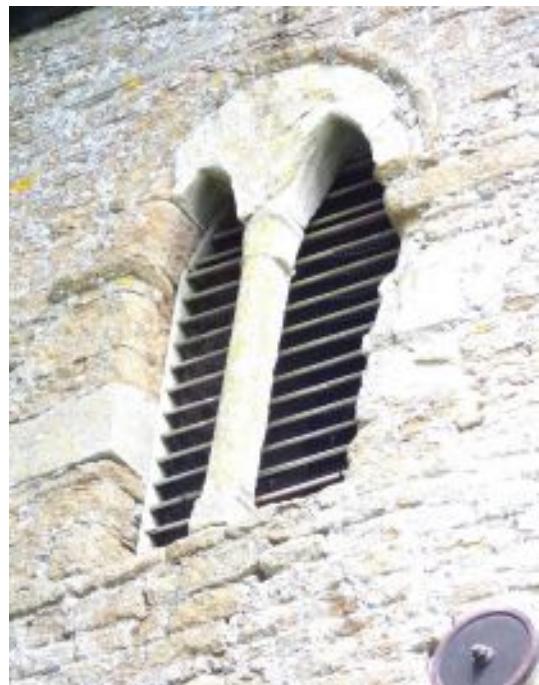
- iv To the belfry stage again some limestone blocks, especially this time on the eastern corner and at least 4 blocks are badly weathered and delaminating, having been vertically edge bedded. Some of these blocks, particularly on the east face, are in very poor condition and replacement is needed having gone beyond the stage of trying to consolidate these, also some evidence of past cracking at high level to the rear of the corner stones extending up to the roofline. Some patch pointing in the recent past to various open joints but much more needed. The central belfry window has a vertical limestone mullion and most of the arch is of limestone but there is also ironstone to the jambs and to the lower part of the arch on the west side. Some of the jamb stones, particularly on the east side are quite weathered. Ironstone at very high level appears to be in a better condition than seen lower down but still some need for consolidation and there are signs of cementitious mortar being used immediately beneath the guttering.

- i Generally seen above the nave roof, limestone blocks to the corner, particularly those on the southern corner, are in poor condition at belfry level and some replacement is now needed. Ironstone walling generally, which has been repointed at various times, including using cementitious and inappropriate mortars. The removal of the inappropriate mortars and stonework consolidation is now needed. The gable also needs careful consolidation and some of the coping stones, as reported elsewhere, are in a poor condition.
- ii There is a rectangular window overlooking the ridge of the nave, patras plate visible on the south side of the roof associated with the internal cage strengthening of the tower. Repointing and consolidation is needed around the kneeler on the south side of the gable. On the north side there is

*Above: Belfry window to the tower south face. Below: View of the tower east elevation. Bottom: Stonework detail to the east face of the tower.*

cracking up to 12mm wide vertically behind the stones to the corner with open joints evident. At lower level some evidence of more recent repointing. There is an old iron cramp, which is now open ended at the northern end, having come loose from whatever fixing point it was designed for. Clearly movement has been along-standing issue in this corner, perhaps now stabilised by the new internal cage, nevertheless there is still a need for external consolidation and repointing (approx 15 m<sup>2</sup>). The external ironwork needs to be repainted. The central rectangular window has a vertical central bar, possibly originally glazed and this being part of the fixing of the glazing.

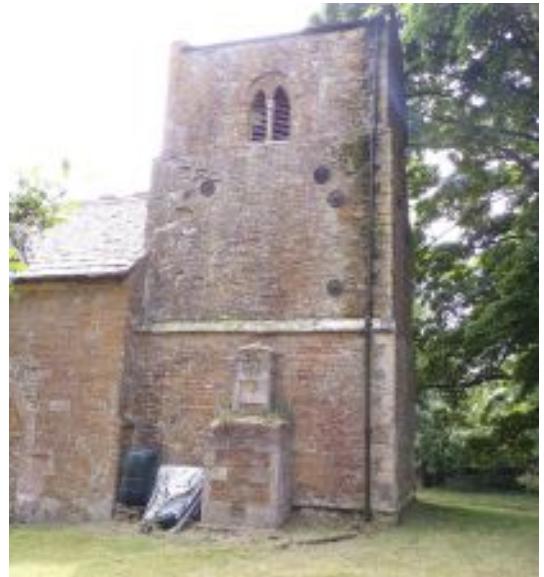
- ii Most of the stonework to the lower stage is in reasonable condition but there is some past poor cementitious ribbon pointing near to the abutment to the nave and in this area some patch pointing and lime mortar is desirable, also some need along the top of the wall and to the plinth aforementioned. Staining down the back of the downpipe indicates that there is leakage from joints and there is also further ribbon pointing in cement in this zone. Limestone blocks to the western corner seem in reasonable condition.

- iii The middle stage of the tower contains 4 patras plates associated with internal tower strengthening – these may benefit from repainting in the next 5 years. Limestone blocks to the eastern corner appear in reasonable condition. There is a band of decayed ironstone towards the eastern face and some renewal and consolidation is needed here, one or two stone blocks are badly supported and may fall off. To the middle of the wall there is some light erosion of the ironstone and some need for patch pointing. Towards

*Above: View of the tower north face. Below: Lower stonework and buttress to the tower north face. Bottom: Belfry level to the tower north face.*

the western corner some evidence of some ribbon pointing in cement, which ideally should be removed and replaced. Some cracks at lower level have been repointed in this stage towards the eastern corner and to the angle to the nave, somewhat crudely done and again evidence of gradual movement needing monitoring or remedial work. Some of this may have been controlled by the installation of the safety cage inside the tower.

The belfry stage has shallow offsets, now missing effective offset detail so water is running down through the joints to the lower stonework. A small amount of weed growth to the remaining bit of offset on the western corner. The lead weathering to the base of the belfry opening/cill, the belfry opening has a limestone replacement mullion then generally an ironstone surround, which is weathered in places but probably still satisfactory subject to a certain amount of repointing (approx 10 m<sup>2</sup>). High level stonework beneath the guttering is in need of repointing, which should be sensitively carried out by an appropriately skilled stonemason. Open joints behind the corner of the parapet extending down to the lower stonework on the eastern corner and some weathered stonework on this corner. Most of the stonework to the belfry stage is ironstone and appears in reasonable condition viewed from below but still a need for patch pointing, and to an extent the condition of the stonework is disguised by moss and algal and lichen growth. Weed growth the rear of the hopper and some pointing up of open joints behind the hopper needed.

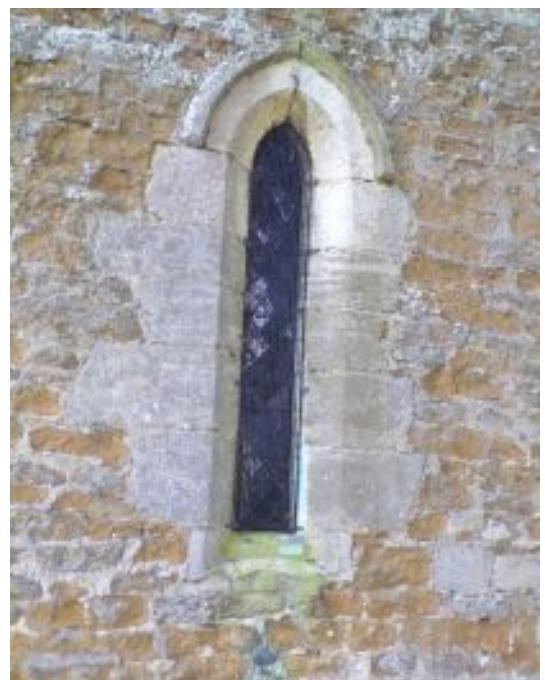
- iii The belfry stage contains 2 light wide window, generally with limestone to the top and mullions – the mullion in this case appears to be still old and pre-Victorian. Around the top of the window is an ironstone hood mould, which is weathered but is still satisfactory. Limestone blocks generally to the corners but some ironstone blocks on the southern side at lower level, which are rather more weathered. Ironstone to the top northern corner in need of consolidation in particular but a lot of the pointing appears to be quite fragile and likely to need removal and repointing/careful consolidation using lime mortars by a skilled mason (15 m<sup>2</sup>). The top gable has again evidence of some need for consolidation, again also the use of inappropriate mortars for past work. Careful consolidation by a stonemason is required and the top cap stone may not be completely stable.

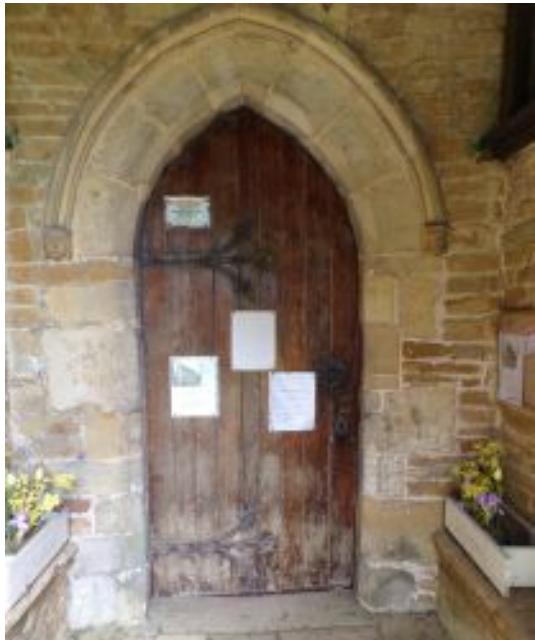
- i There is now only one door to the church, the priest's door having been infilled. The door is in the inner porch, of oak, probably Victorian in date with decorative band hinges and loop handle. The hinges are rusting and would benefit from cleaning down and repainting, the door has had a varnish finish in the past, which is now weathering away in places and the door appearance would be improved by careful preparation and re-varnishing or else removal of the varnish finish and oiling.
- ii There are no timber porches or canopies.

- W1 Lancet window to the east wall of the chancel, limestone surround, the top arch stone was originally one piece but now cracked, the crack having perhaps reopened slightly, the crack then extends through a carved figure within the angle of the arch. The window stonework contains evidence of a past window guard, now missing, the window glazing contains painted and patterned glass, slight bowing but leading generally seems in reasonable condition and glass is satisfactory. The window guard is a modern powder coated stainless steel guard, which is in a good condition.

- W2 In the east wall of the chancel, lancet window with limestone surround, the surround generally in satisfactory condition but some repointing to open joints desirable. There is a stainless steel window guard fitted; there is copper staining onto stonework from a previous guard. Window glass is patterned and coloured, leading seems in reasonable

Above: Porch door into the church. Below: Lancet windows to the chancel east elevation. Bottom: Western window in the nave north elevation.

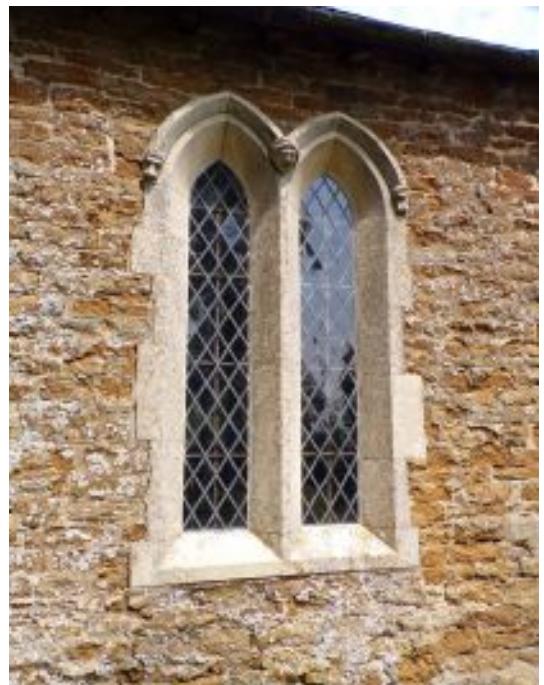
W7 In the south wall of the south aisle, west end, Victorian with limestone surround, which is generally in a satisfactory condition but some cracking around the back of the jamb on the west side and fracture to the base of the cill to the western panel. Window glass is generally clear diamond leaded glass, which is in a good condition having been repaired since the last inspection. The internal saddle bars are rusted and would benefit from cleaning and repainting.

W8 South wall of the south aisle, centre, 2 light wide lancet type window, Victorian and limestone surround generally in good condition, window glass is clear leaded lights, buckled in places and comes are weakening and one quarry has rotated outward to the eastern panel, leaving a gap. Re-leading in the near future and repairs by a glazier needed, the internal saddle bars are rusted and would benefit from cleaning and repainting.

W9 To the south wall of the chancel, east end, 2 light wide lancet window with ironstone head, having limestone hood moulds, limestone mullion and limestone jambs and cill, although with ironstone cill on the eastern light. To the back of the jamb on the east side wide pointing, recent to fill in a gap but some evidence that the gap has reopened, also 2 pins noted at higher level to the jamb associated with some kind of monitoring regime. Window surround generally satisfactory but the ironstone to the top is decaying

Above: W7 to the west end of the south aisle south elevation.  
Below: Detail to the central window in the south aisle south elevation. Bottom: W9 to the east end of the south aisle south elevation.

lightly and there is evidence of rather crude pointing in this area. The jambs are in reasonable condition, there is some need to consolidate the base of the mullion where the ironstone sill is cracking and new studding to the base of the mullion may be required to make sure the mullion is supported properly. The window glazing is Victorian diamond leaded glass, which appears to have recently been repaired, although the eastern pointing has spalled away (2 linear metres). Internal ironwork/ferramenta is lightly rusted and would benefit from cleaning and repainting.

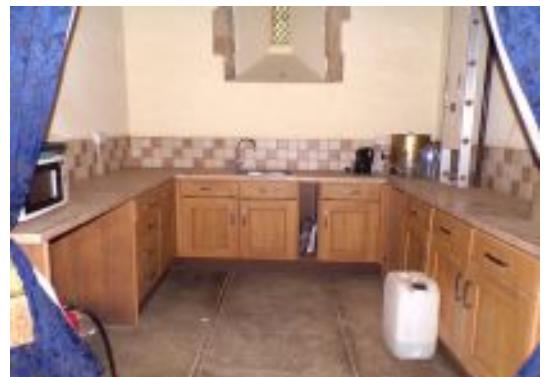
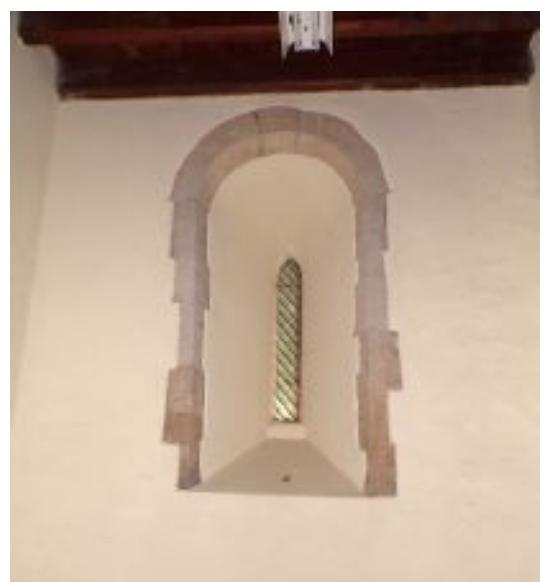
Above: Interior of the tower base. Below: West wall of the tower base and lancet window.

- iii Walls: Generally of painted plaster, the plaster seems quite hard and may be a cementitious mix, also noted by the way it stands proud of the stone surround on the west wall. The west wall contains a single lancet window with a deep reveal, exposing the fact that the wall thickness is over a metre. The keystone to the top of the inner arch is possibly loose and cracked each side and would benefit from some stabilisation and some pinning. A slight crack down the back of the jamb on the north side of the window. The north and south walls are basically plain painted plaster and in the north wall there is extensive evidence of past vertical cracking extending on this wall full height, which has been infilled in the past on probably more than one occasion but hair cracks remaining to the repaired sections. Some of the plaster sounds hollow including around some of these refilled cracks and so part of the problem may simply be some de-bonding plasterwork. Nevertheless there is perhaps still the potential for some movement to be occurring despite the restraint provided by the cage at higher level below the bell frame level and further consolidation of the stonework is probably still needed. The east wall contains the back of the tower arch, there is a bit of a slight crack on the south side near the top of the arch, which extends into the plasterwork above and a potential for some plaster at high level to be loose. To the base of the northern respond to the tower arch some patching up of the vertical surface has been carried out using cementitious mortar.

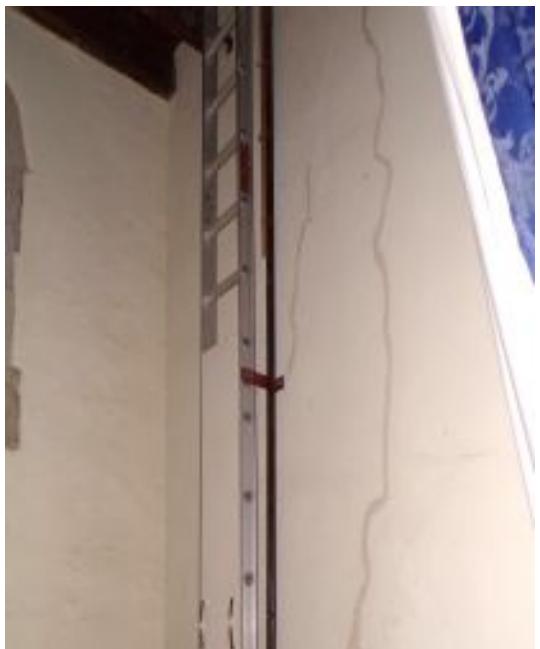
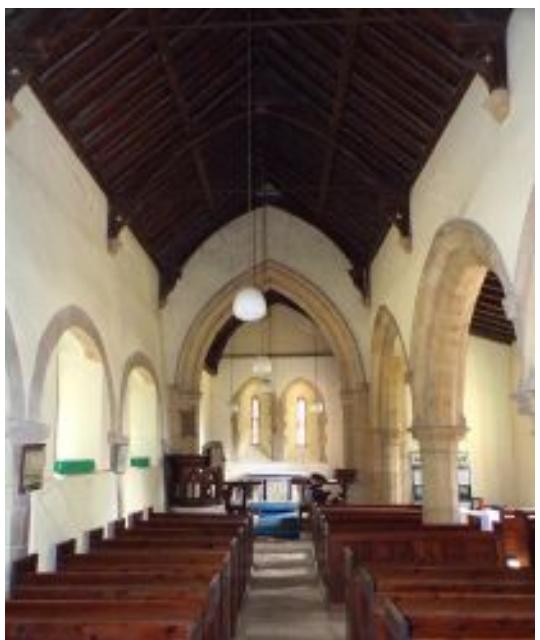
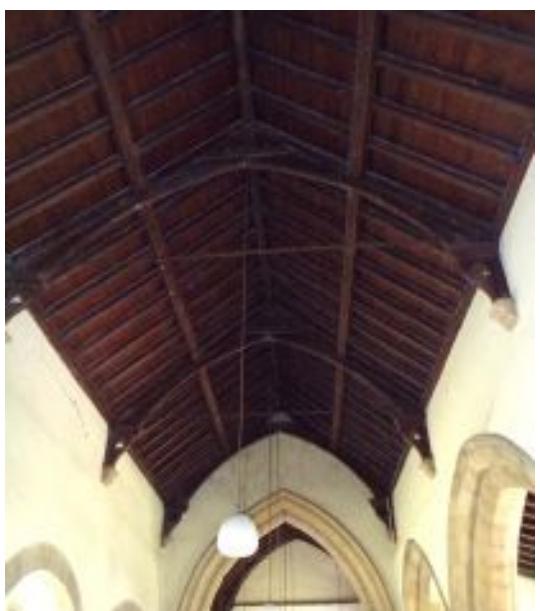
Above: Tower base north wall. Below: View of the nave interior.  
Bottom: Nave ceiling structure.

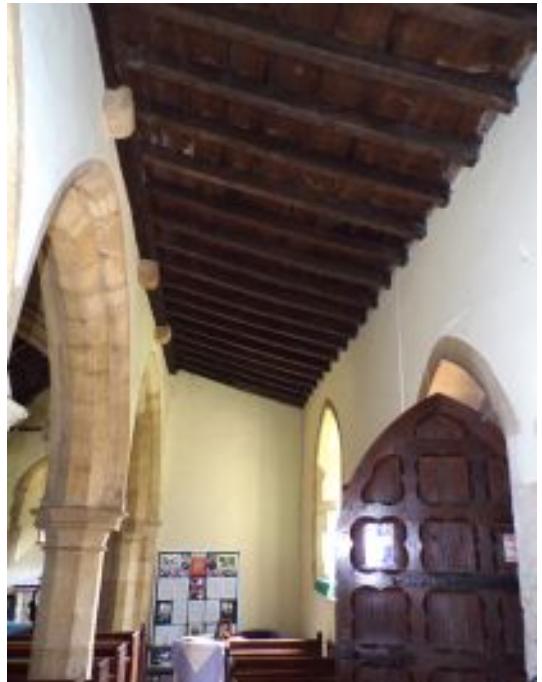
- ii South Aisle: Consists of a top rail/wall plate supported on stone corbels with common rafters extending down to the top of the wall with no obvious wall plate, the wall plate being imbedded behind the plaster. Roof boards are wide old planks, one or two areas evidence of water ingress, eg above the entrance door at the back of the central arcade arch and near to the eastern parapet in various places. The easternmost rafter has been spliced and repaired about mid-distance with a simple scarf, which is rather inadequate but part of the rafter is supported by the wall. Generally at the moment, viewed from the underside, the roof appears in reasonable condition but there is extensive white staining in a number of places, also towards the western wall where water ingress has been an issue. Cleaning down of the roof structure and making good of the roof stain may help improve appearance and also help register where ongoing water ingress may be an issue.

- iii Porch: Victorian roof structure with high collars and then common rafters forming separate trusses with vertical posts to inner wall plate and extending to the outer wall plate, the rafters extending over the stonework externally. Some decay in the rafter end of the west side on the southern gable, the rafter end on the east side has rotted away against the southern gable. Rafter ends generally extend into stonework/

Above: View of the south aisle ceiling structure. Below: Some white staining to the south aisle ceiling. Bottom: Porch ceiling structure.

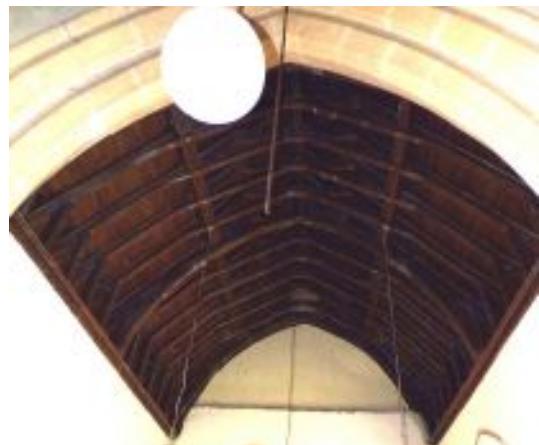
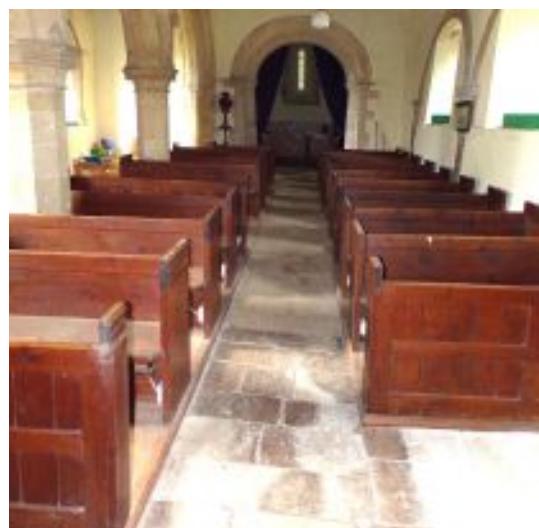
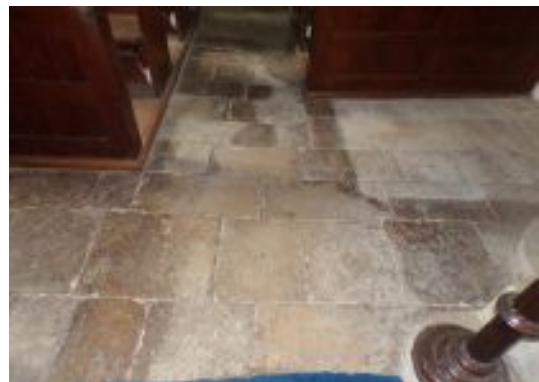
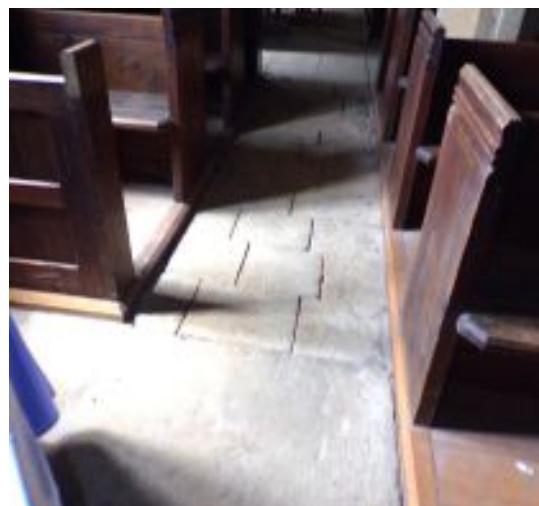
Above: Chancel ceiling. Below: View of the nave central aisle-way. Second below: Stone flags to the west end of the nave floor. Bottom: South aisle flooring.

- i Nave: The central aisleway is of stone flags, relatively small in size and possibly ironstone. The stone flags have settled, most noticeable getting to the north side towards the east end of the nave with the corresponding rise back up to the outer wall alignment/aisle location. Cause for any dipping is not clear but some settlement must have occurred in the past. A few of the stone flags have been pointed up around the edges at the east end with cementitious mortar, which is inadvisable. If any gaps need filling the use of a hydraulic lime mortar is preferable. Some of the stone slabs at this end also have a kind of glaze to them but no attempt should be made to re-seal the floor in the future, any sealant that gives the floor a slight sheen seems to be historic and is not modern. The stone cross aisle also extends towards the south door. Pew platforms have an oak edging and then softwood boarding and all softwood boarding appear to be fairly new and presumably a fairly recent replacement and all seems to be sound. These incorporate a number of ventilation grilles with insect mesh installed above and located and concealed beneath pew seats to hopefully help reduce the risk of decay occurring again, although if the floor conditions are damp there may still be a risk of decay. The decay in the floor may have occurred because of damp conditions around the building generally and again is a signal that drainage issues need to be addressed.

- ii South Aisle: A walkway of stone flags, generally in satisfactory condition and the area widens at the west end of the aisle around the font. The floor is relatively level and is in reasonable condition. A stone step is raised around the font area. One or two replacement flag stones behind the entrance door and one or two slight gaps have been filled in the past with cementitious mortar, which has broken up and worked loose. To the section of pews in the south aisle are again of new softwood boarding with the underfloor not ventilated.

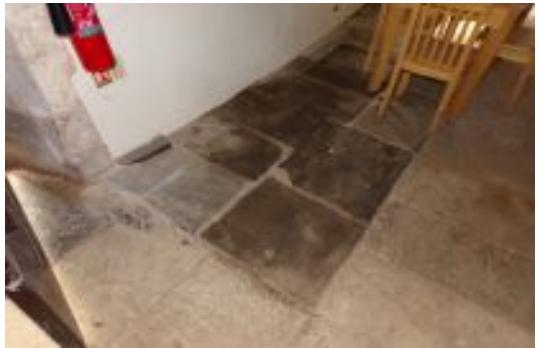
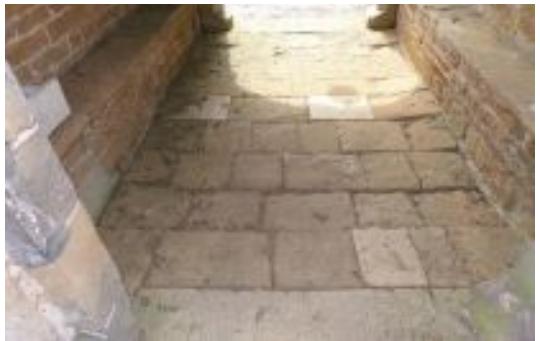
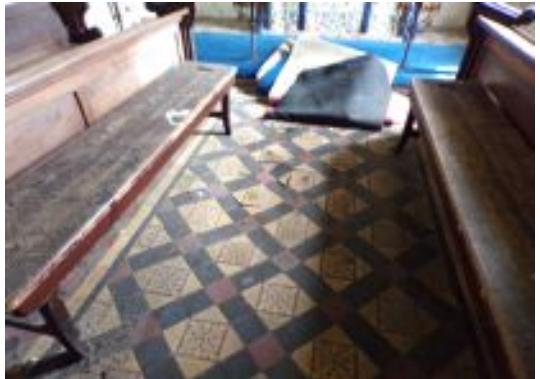
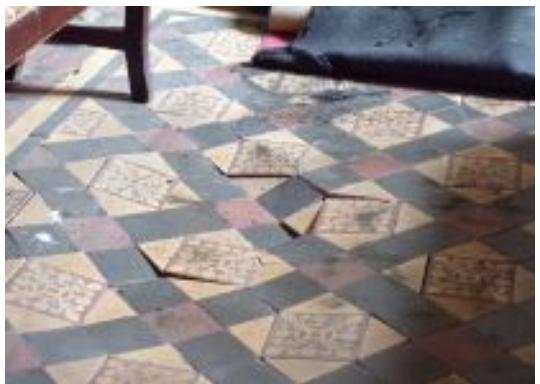
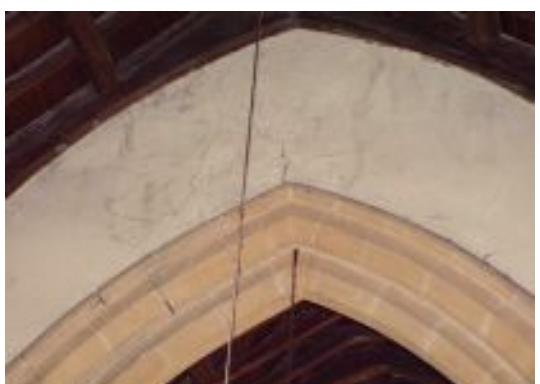
- iii South Porch: Stone threshold to the door and then ironstone flag stones. The ironstone has weathered and is becoming uneven, particularly inside the immediate threshold to the outer doorway and on the east side there is a stone raised up by about 30mm, which could be a trip hazard. In the foreseeable future some re-levelling of the floor is going to be needed to avoid trip hazards becoming worse. Ironstone is an unusual choice of flooring as it is not known for its wearing characteristics but is a distinctive feature of the entrance porch and some debate might be required as to what appropriate replacement material might be for those most weathered stone blocks that cannot be reused.

*Above: New stone flags to the west end of the south aisle.  
Below: Porch floor. Second below: Chancel floor below the carpet. Third below: Subsidence in the chancel floor. Bottom: Nave east wall chancel arch high level walling.*

Chancel: The chancel step is probably of sandstone and part of the Victorian restorations, discoloured to the leading edge but basically in a satisfactory condition where visible. A central carpet runner is laid on a rubber underlay and this underlay is deteriorating, a replacement with a breathable alternative eg. traditional felt, is recommended. The carpet covers a Victorian geometric and encaustic tile floor, which has subsided over the last 5 years over an area of approx 2 metres to a depth of 75mm. This needs to be urgently investigated. In the sanctuary area the front part of the sanctuary step and the zone in front of the altar is covered with the same blue carpet, again laid on rubberised underlay and covering an encaustic tile flooring. To the choir stalls replacement softwood boarding, which generally seems to be in reasonable condition.

i East wall: Contains the chancel arch, stonework is generally ashlar and probably Victorian in date. Two centred arch with octagonal responds, above the arch the wall is generally plastered. There are a number of opening joints in the north side of the arch, possibly indicating that the north side of the wall is moving outwards. Above the arch there are 2 cracks approx 5mm wide to the apex of the arch and 3 cracks to the north side of the arch leading to the eaves to the main roof on the north side. Plaster in these zones may be potentially loose and should be checked as part of any structural investigation. The plasterwork is looking slightly uneven towards the top of the arch. This may have occurred gradually since the chancel was rebuilt/strengthened by the Victorians, however this seems to have worsened since the last inspection and needs to be considered as part of structural issues evident in the church.
