# **quinquennial inspection**

**church of st. mary • chadwell**

**pcc of st. mary • wycombe & chadwell**

date of inspection: 9th july 2021

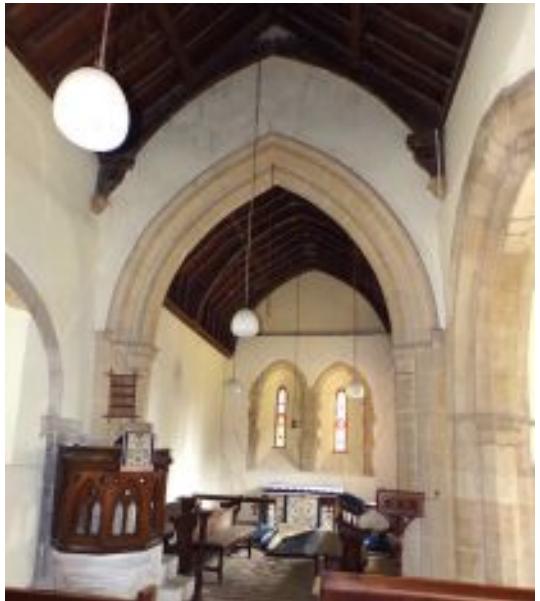
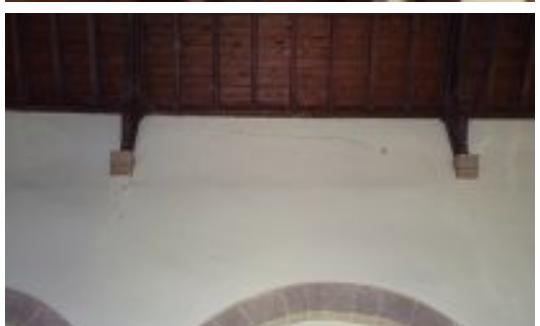
ii West wall: Contains the tower arch with an ancient and impressive 12th century arch, the responds to which have a distinct and pronounced backward lean, particularly that on the south side. The movement appears to be historic but nonetheless notable. The base stone to the respond on the south side appears to have been renewed at some stage and there is an indication that the floor levels have been altered at some point and the base is approx. 18" above the nave floor level. Above the arch the wall is generally plastered with an offset corresponding to the lower stage of the tower. Some streaking on the plaster indicates some roof leaks from the edge abutment to the tower. There is cracking in the plaster running around the back of the arch on the north side extending vertically up the tower almost

*Above: View of the nave east wall chancel arch. Below: View of the nave west wall tower arch. Second below: Nave north wall. Bottom: Cracking at high level to the nave north wall.*

full height towards the purlin. There is a radiating crack towards the eaves in the main roof on the north side of the nave. There is potential for areas of plaster to be loose and the cracking in the plaster, which must have occurred since the last redecoration, is also noteworthy. Further slight cracking down the back of the plaster near to the northern corner at lower level and the plaster has been patched in the past at low level. There is slight algal bloom on the lower stonework of the respond on the south side.

- iii North wall: Contains the old infilled arcade to the north aisle, now missing and the pillars are still imbedded between windows and are clearly early Norman in date with Norman arches expanding across the tops forming the inner lintels to the windows. The windows are Victorian in date and the stone surrounds appear in satisfactory condition, window ironwork would benefit from repainting. Around the arcade and also within the walls are generally plastered and painted. There is a crack 2 - 3mm wide to the west end of the wall above the western pier of the in-filled arcade and above the central arcade arch indicating ongoing movement. There is cracking around the inner line of the arch to the westernmost arcade and also to the inner reveal of the arch of the window. Also there has been crack that has been filled in but has reopened leading from above the easternmost pillar location towards the corbel, and then up towards the eave. A similar filled crack, which has not yet reopened, can be seen from the eastern pillar up towards the corbel. One further crack, which has been infilled and not yet reopened significantly is above the eastern side of the easternmost arcade arch and a further crack radiating slightly from the corbel stone against the east wall. Some areas of plaster do sound hollow and there is a potential for some need for localised consolidation as and when the redecoration happens, although plaster appears to be perilously loose at least superficially.

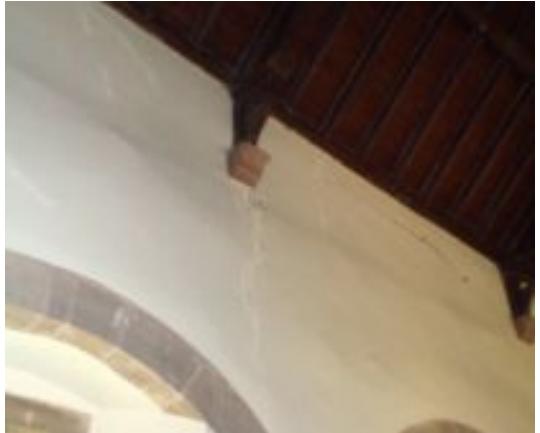
- iv South wall: Contains 3 bay arcade to the south aisle with octagonal pillars and octagonal responds, the arcade has 2 centres arches, which are early English or thereabouts in date. Simple crude figurative heads to the bases of the hood moulds above the arches above the pillars. Offset to the top of the arcade arches in the main wall indicate the original roofline and then above this a vertical section of wall, which would once have contained a clerestory and was then removed again by the Victorians. A stone corbel supports the edge of the Victorian roof. The wall above the arcade is generally plastered, painted and in satisfactory condition but there is a radiating crack near the top of the easternmost arch running up towards the corbel of the roof to the west and the arcade arch is displaced by about 1" to 1.5". The movement may well be old and the radiating

*Above: Cracking to the eastern pillar of the nave north wall.  
Below: Nave south arcade. Second below: Western arch of the nave south arcade. Bottom: North arcade of the south aisle.*

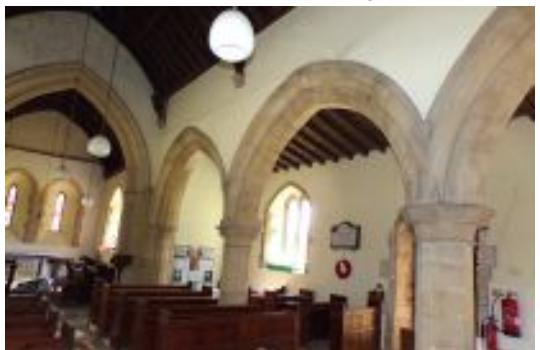
crack has reopened since the last redecoration by a modest amount. Above the centre arch of the arcade there are some almost horizontal cracks, which have been filled in in the past, and one vertical crack from near the west side of the westernmost arcade arch. These cracks have been filled but have re-opened since the last inspection. Exposed stonework to the arcade arches and pillars generally seem to be in good condition.

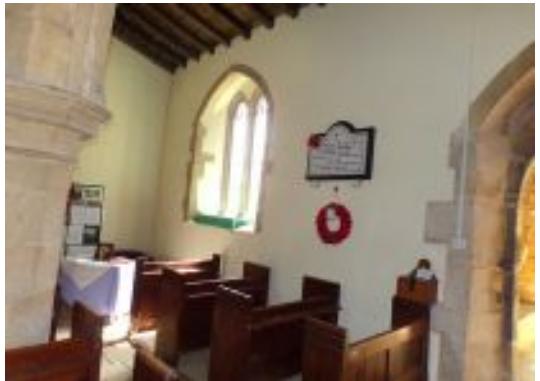
- ii South wall: Contains the south entrance door and 2 windows, wall around is generally plastered but exposed stonework to the Victorian replacement window, inner arch and outer stonework. To the western window west side some cracking to the reveal to the back of the jamb and below the window, again some evidence of cracking and misalignment of plaster indicative of some movement in this zone since the Victorian rebuild. Towards the eastern corner again some infilled cracks at lower level and one above the window radiating up to the roof level, which have been infilled as part of past redecoration but have reopened. To the door exposed stonework, probably Victorian replacement to the top arch and then the jambs appear older but with some replacement stones. The door is Victorian in date and is in a satisfactory condition, although the centre board has split allowing some daylight through. There is further cracking and plasterwork deterioration to the west end of the wall indication both water penetration and movement issues.

*Above: South aisle south wall east end. Below: South aisle south wall west of the entrance door. Second below: Nave east wall. Bottom: Cracking to the nave east wall.*

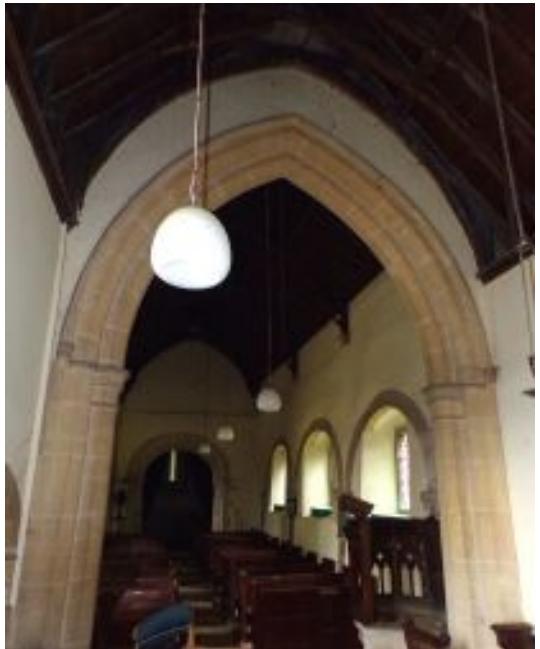
- ii West wall: The wall is the back of the chancel arch, the arch stonework generally is Victorian ashlar work, there is movement and displacement in the arch on the north side including to the outer hood mould, displacement of about an inch and radiating cracks along the back of the various layers of the arch generally. Cracking then extends up towards the top of the arch into the plaster above. There is loose plaster at high level.

*Above: Chancel west wall chancel arch. Below: Cracking to the angle of the chancel east and south walls. Bottom: Porch north wall and doorway into the church.*

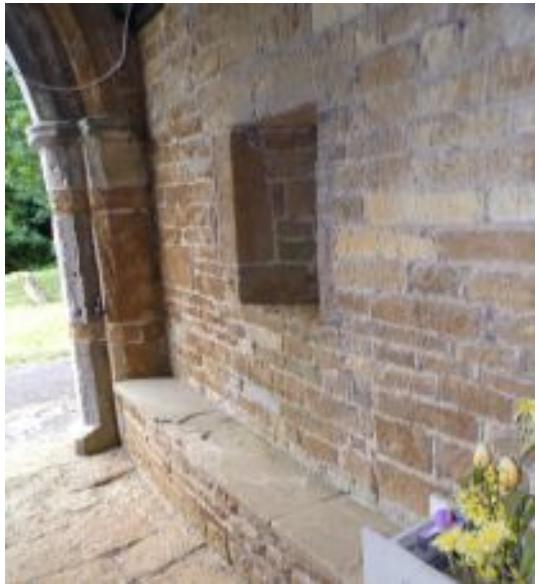
- iii West wall: A bench seat at low level, the seat is delaminating the top being of limestone, the base to the seat is of ironstone and the walling generally of ironstone with ironstone lintel to the slit window. Some loose pointing and a slight vertical crack leading above the south side of the window but generally all in a satisfactory condition at present. A slight open joint where the porch abuts the aisle wall.

Above: Porch west wall. Below: Pews with under pew heaters installed. Second below: The font. Bottom: The pulpit.

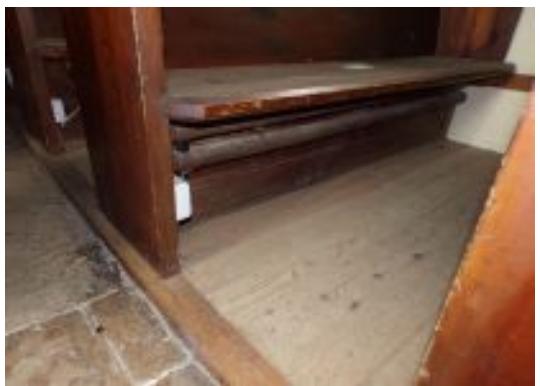
- i Pews are generally Victorian in date, being of pitch pine. Some localised areas of furniture beetle notable in the frontals on the north side of the nave and in the south aisle, also in seats in areas elsewhere. Furniture beetle is not yet significant and pews are generally satisfactory. Under pew heaters are installed to the 5 front stalls. All pews seem to be fairly stable and safe and the floors have been repaired.
- ii In the south aisle are 2 loose children's pews based at the east end of the aisle, these appear to be in reasonable condition.

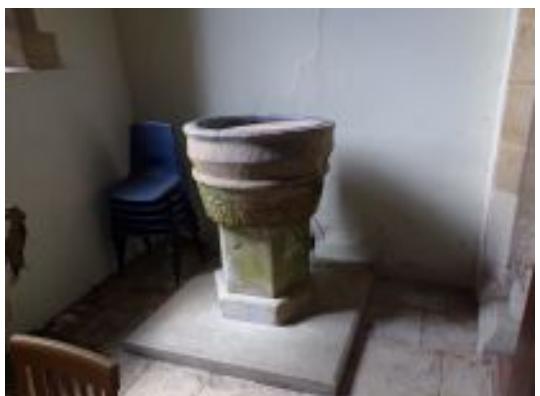
- iv Circular font on a hexagonal base stands on a shallow raised step at the west end of the south aisle and the font is Norman, having a lead lining but the base is later. All appears in reasonable condition but slight algal bloom on the font but not significant at present.

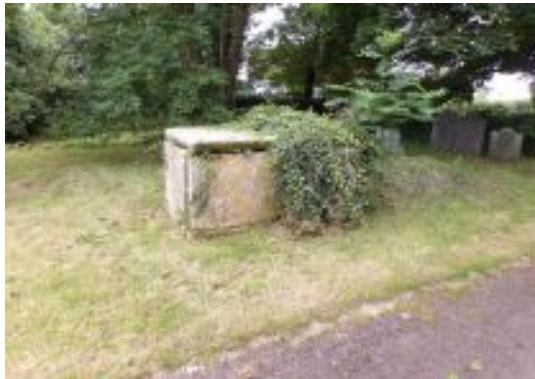
- i A large chest tomb to the south of the porch is separately Grade II listed. This tomb chest is in quite poor condition and needs repair and consolidation; there is a risk of it becoming dangerous and its position close to the path makes this more significant. Grants may be available from the Local Authority or elsewhere for its consolidation.
- ii To the south of the church memorials are mostly of Welsh slate, although one or two are Swithland. Most headstones appear fairly well sunk into the ground and stable.
- iii To the east of the chancel are comparatively few memorials and those present are generally again Victorian or thereabouts in date.
- iv To the north of the church the area of the old north aisle is for the most part free of obvious memorials

*Above: Chest tomb to the south of the church. Below: The pathway and grave markers to the south of the porch. Bottom: South west boundary and hedging.*

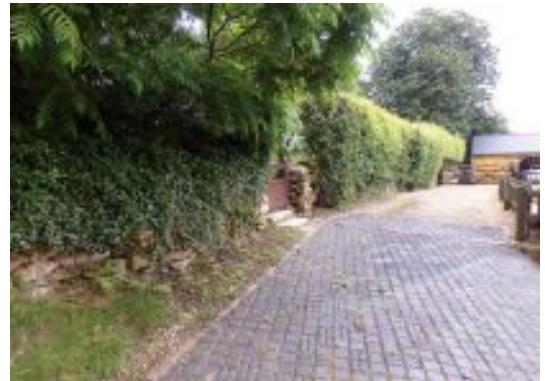
- ii Eastern boundary: Consists of a low dry stone wall consisting of ironstone, there is a gateway from a block paved area leading to the churchyard. The gate appears to be fairly modern and of similar date to the western gateway and again has been repainted recently. There are timber posts to each side, one of which is split and the gate generally is in satisfactory condition, although the gate is binding on the vertical post on the open side. Stone steps lead through the gateway to the main churchyard path.

*Above: Block paving and gateway in the eastern boundary.  
Below: Hedging to the northern boundary. Bottom: The southern boundary and trees growing against it.*

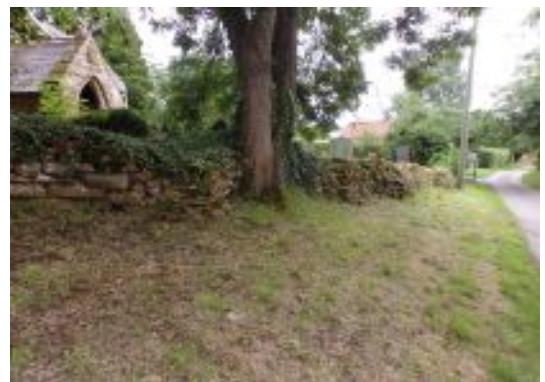
- ii Adjacent and within the southern boundary is a further semi-mature tree and the tree is probably originally self-set, having two main trunks, which are split and grow from the ground level upwards. This tree is probably only semi-mature and again could start to have impact on the church, both in terms of foundations and leaves blocking gutters. Consideration might be given to removing this tree, subject to appropriate consents.
